Washington Ave Bore Crossing Project

Geotechnical Exploration & Evaluation Report

**Final Submittal
Revision No. 1**

March 2021

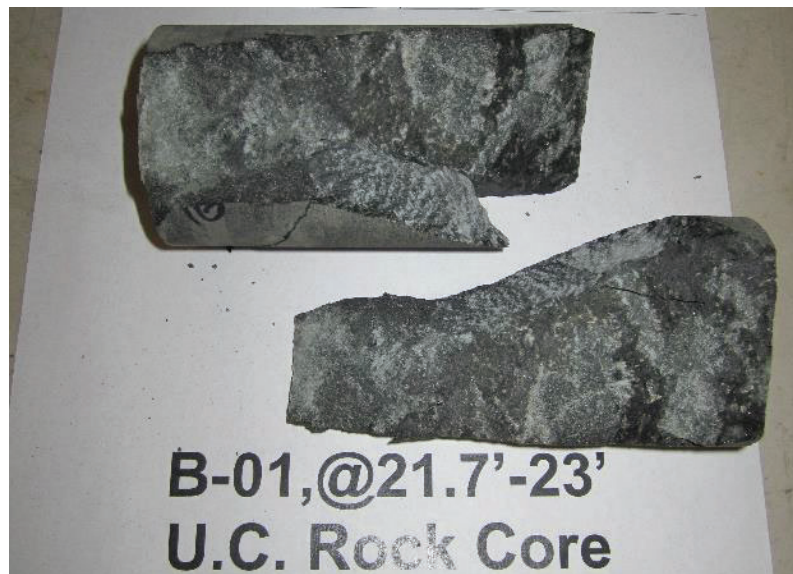
Figure 2. B-1 @ 21.7 – 23.0 Ft. core after unconfined strength testing.

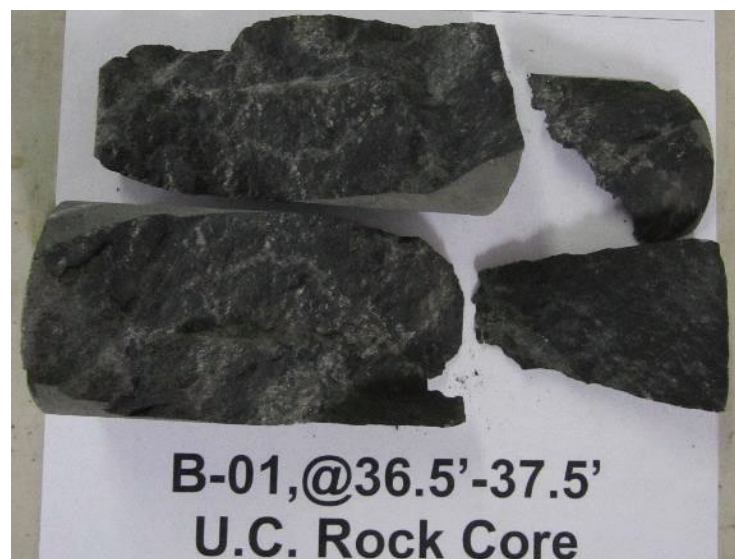
Figure 4. B-1 @ 36.5 – 37.5 Ft. core after unconfined strength testing.

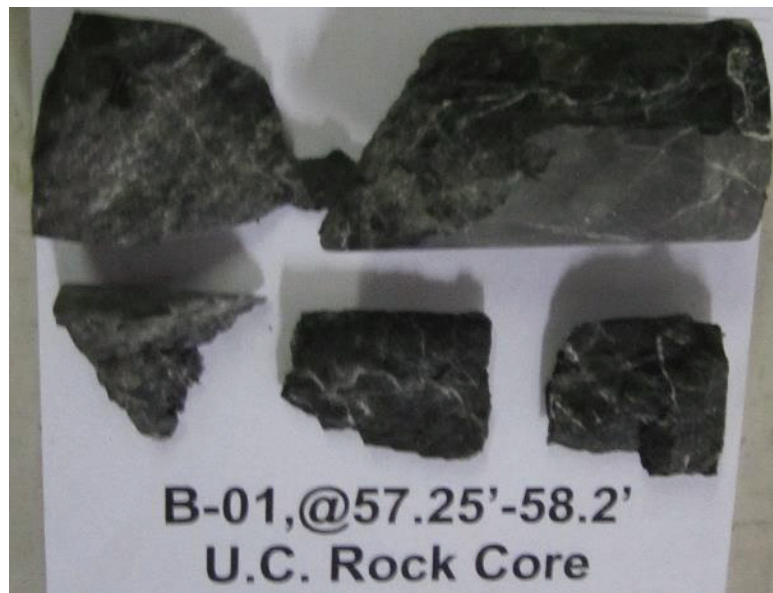
Figure 6. B-1 @ 57.3 – 58.2 Ft. core after unconfined strength testing.

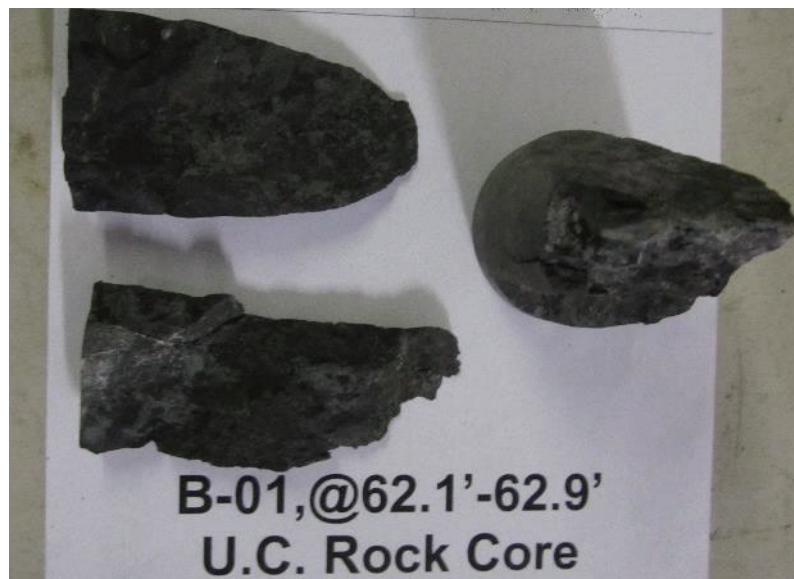
Figure 8. B-1 @ 62.1 – 62.9 Ft. core after unconfined strength testing.

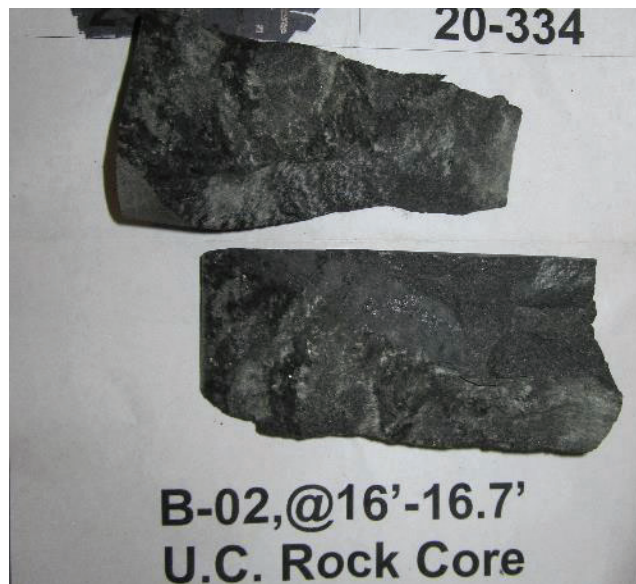
Figure 10. B-2 @ 16.0 – 16.7 Ft. core after unconfined strength testing.

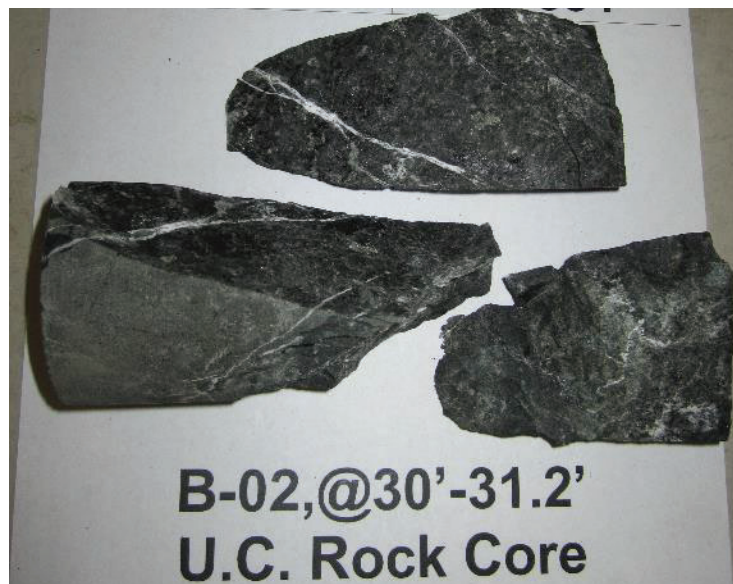
Figure 12. B-2 @ 30.0 – 31.2 Ft. core after unconfined strength testing.

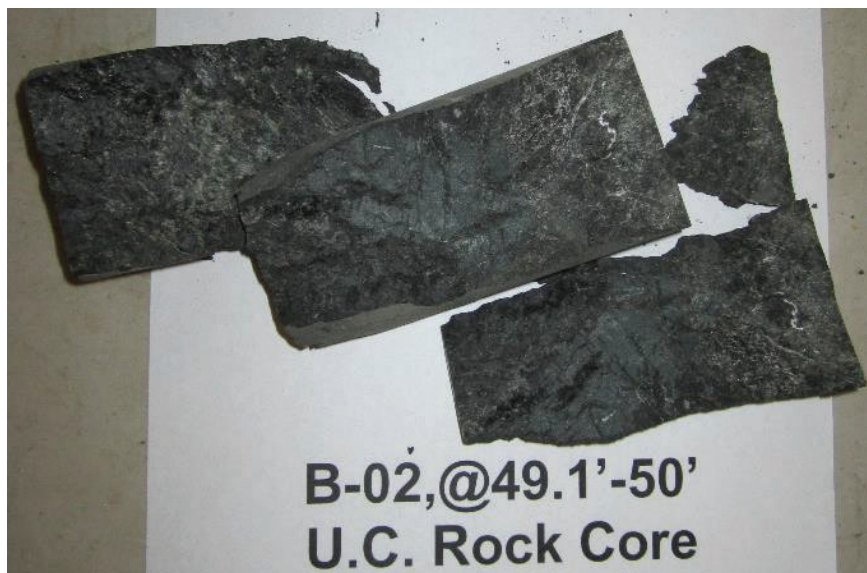
Figure 14. B-2 @ 49.1 – 50.0 Ft. core after unconfined strength testing.

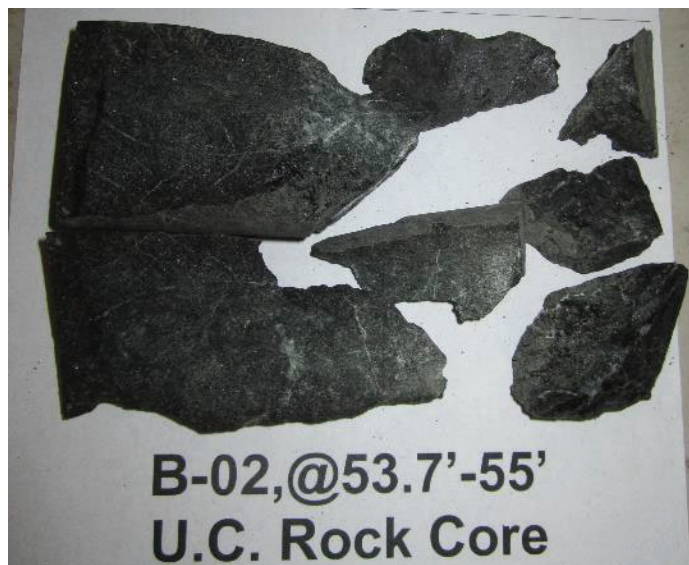
Figure 16. B-2 @ 53.7 – 55.0 Ft. core after unconfined strength testing.
