Appendix H
Facility Data Sheets

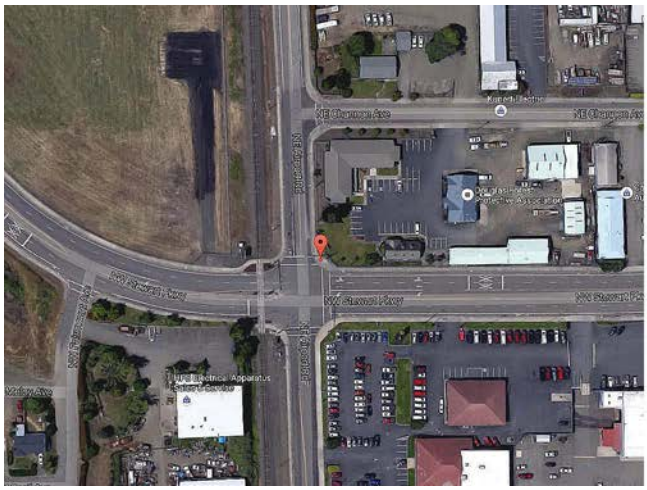
CR_198

Comments: On airport rd

S3_RampSlope: 9.8

S5_WingSlope1: 12.8

S7_CounterSlope: 13.9

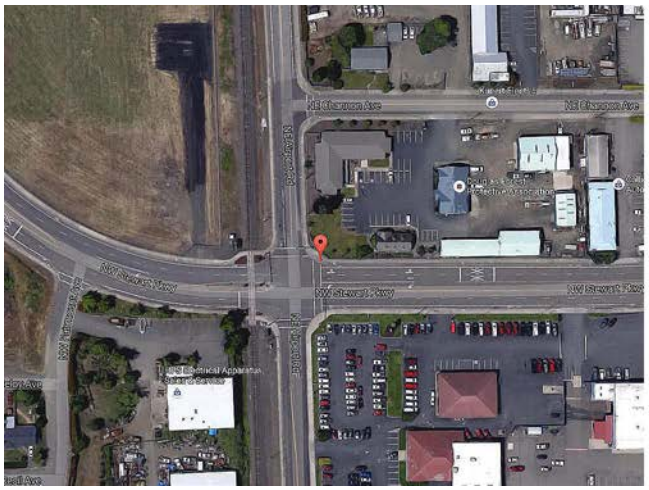
CR_199

Comments: On Stuart pkwy

S3_RampSlope: 8.2

S5_WingSlope1: 11.9

S7_CounterSlope: 16.5

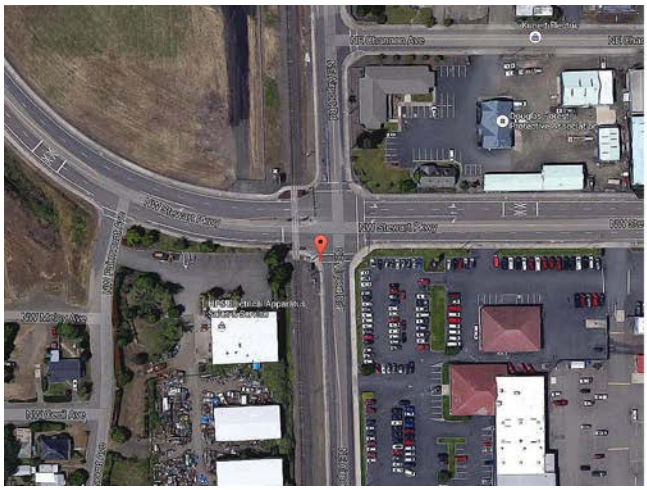
CR_284

S3_RampSlope: 8.4

S6_WingSlope2: 12.6

S7_CounterSlope: 11.8

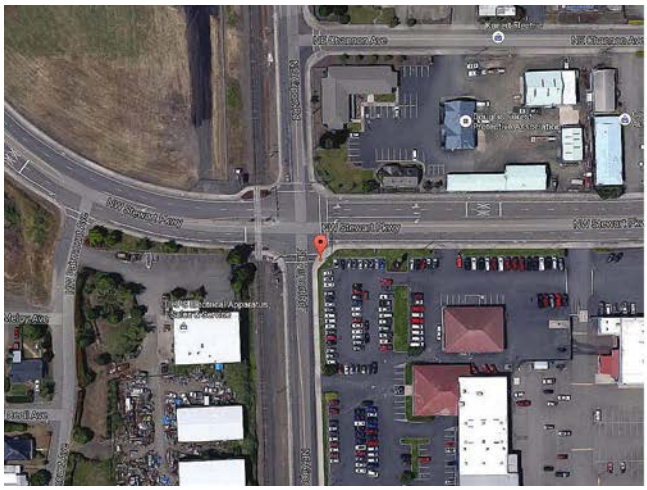
CR_285

Comments: Non compliant ramp on airport

S3_RampSlope: 7.9

S5_WingSlope1: 9.7

S7_CounterSlope: 9.6

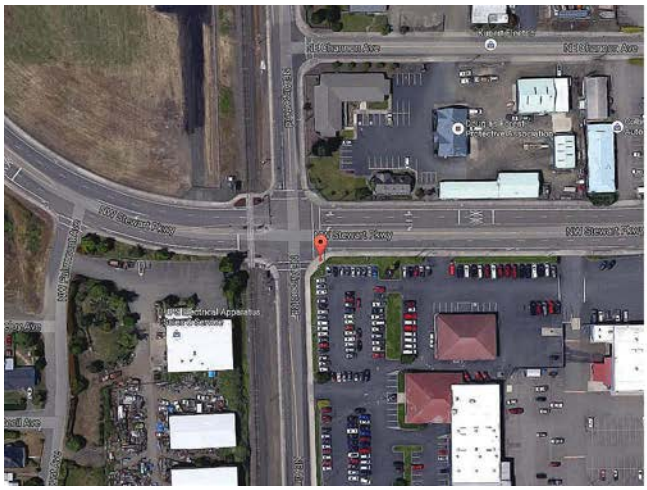
CR_286

Comments: Non compliant ramp on Stewart pkwy

S3_RampSlope: 8.3

S5_WingSlope1: 8.7

S7_CounterSlope: 8.0

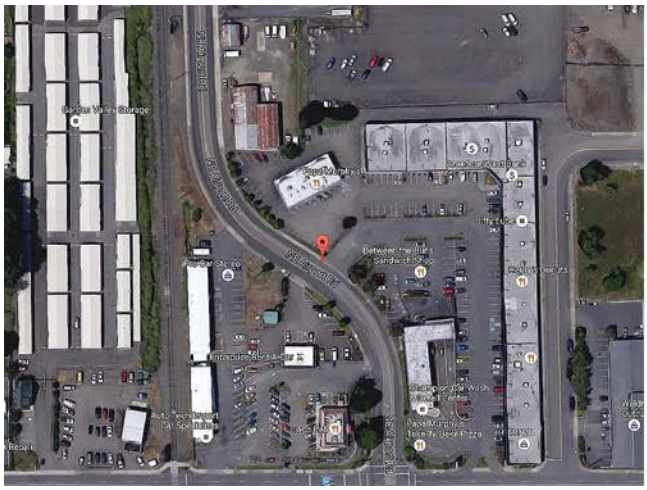
CR_533

Comments: No landing

D3_RampWidth: 2.6

S3_RampSlope: 14.3

S4_RampCrossSlope: 5.8

S5_WingSlope1: 14.6

S6_WingSlope2: 21.1

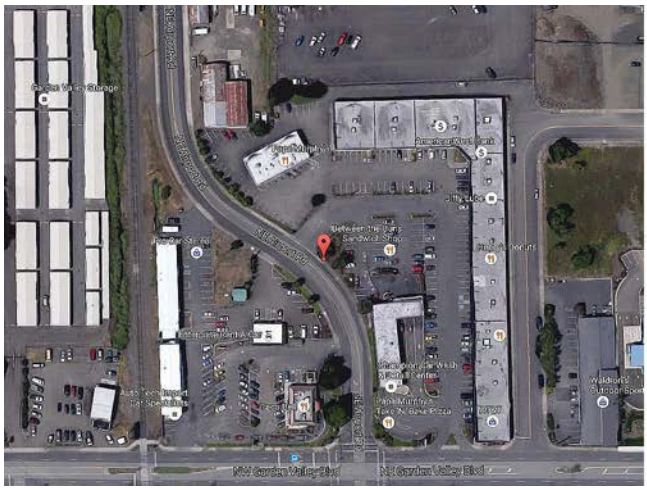
CR_572

Comments: Non compliant ramp no landing

D3_RampWidth: 3.3

S3_RampSlope: 13.4

S4_RampCrossSlope: 7.1

S5_WingSlope1: 29.7

S6_WingSlope2: 21.8

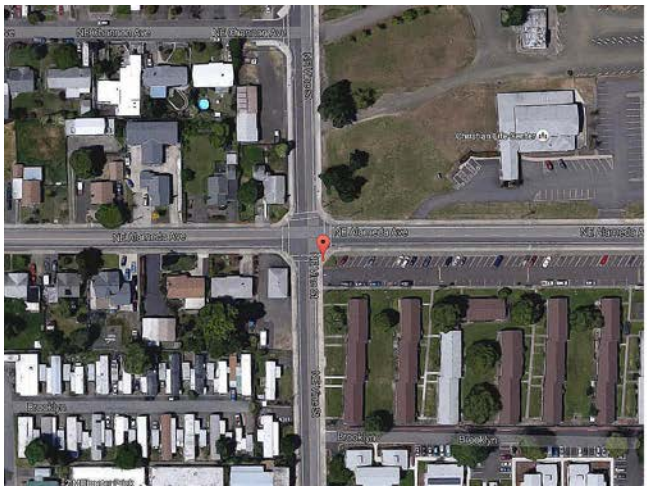
CR_193

Comments: On alameda

S3_RampSlope: 11.1

S4_RampCrossSlope: 4.1

S5_WingSlope1: 13.3

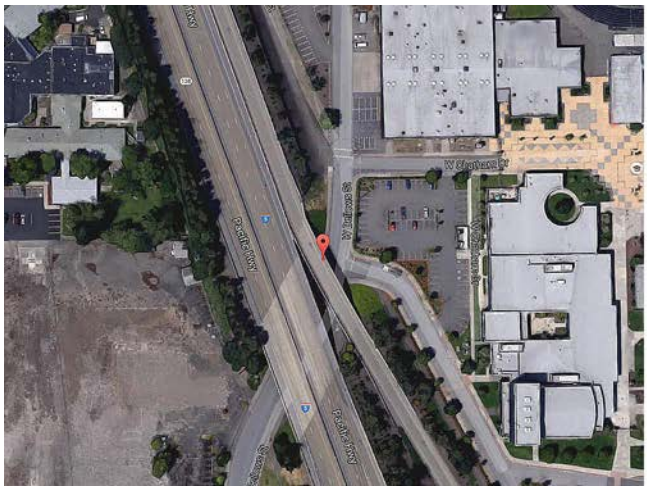
CR_536

Comments: No landing

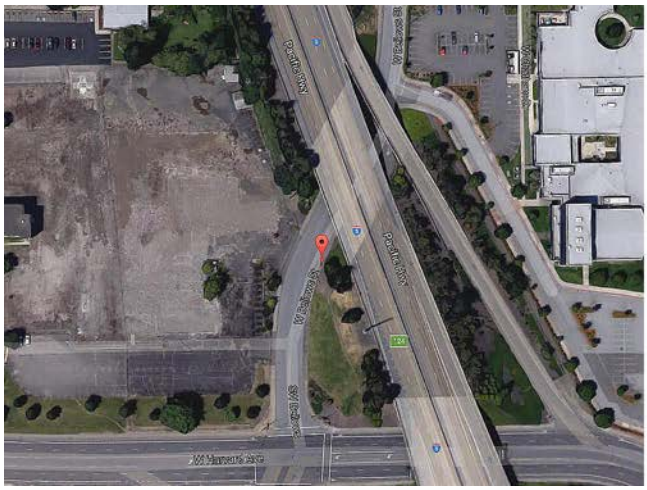
CR_537

Comments: No landing

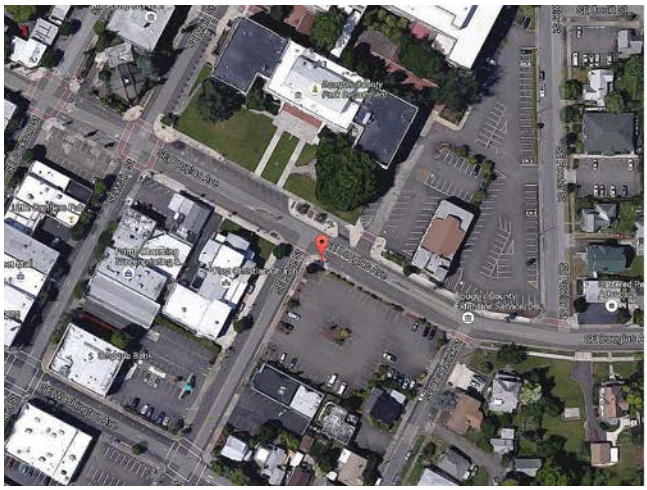
CR_103

Comments: On douglas

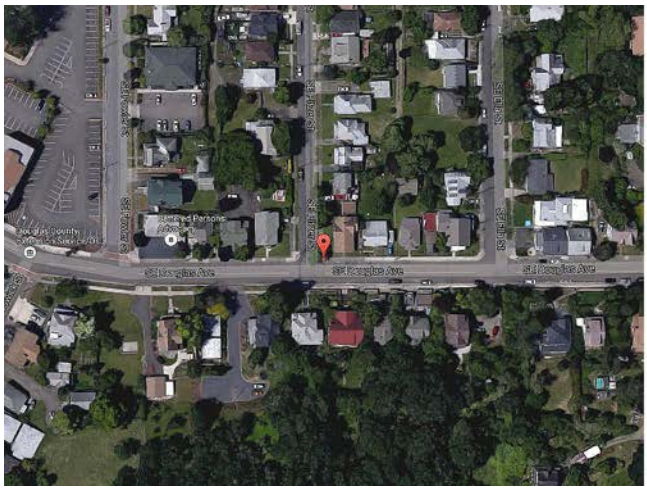
CR_105

Comments: No north wing . Tree in wing

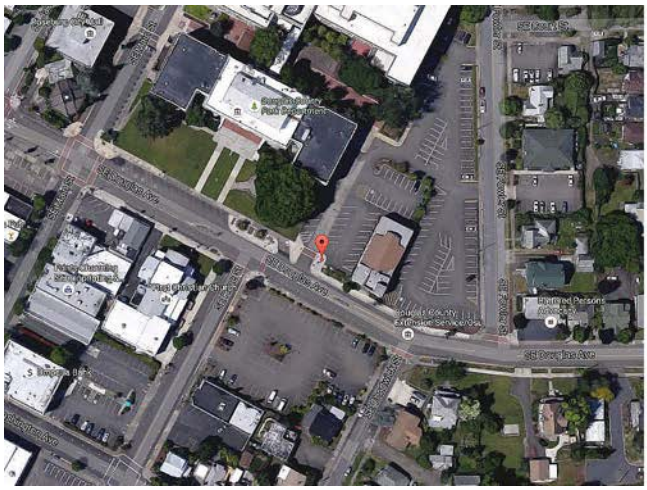
CR_222

Comments: There is a power pole in the landing

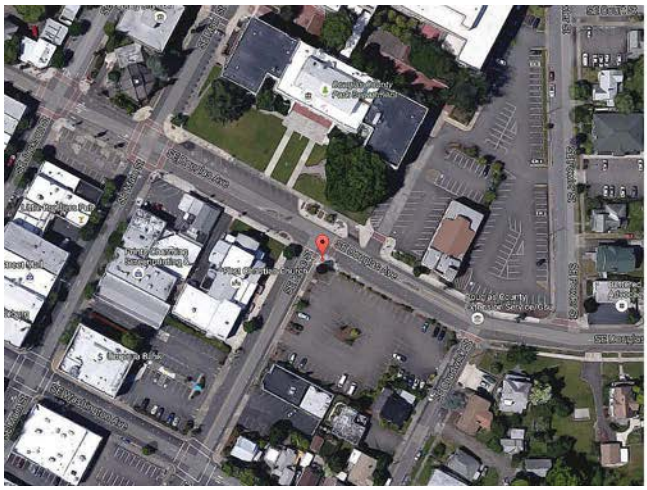
CR_223

Comments: On Kane

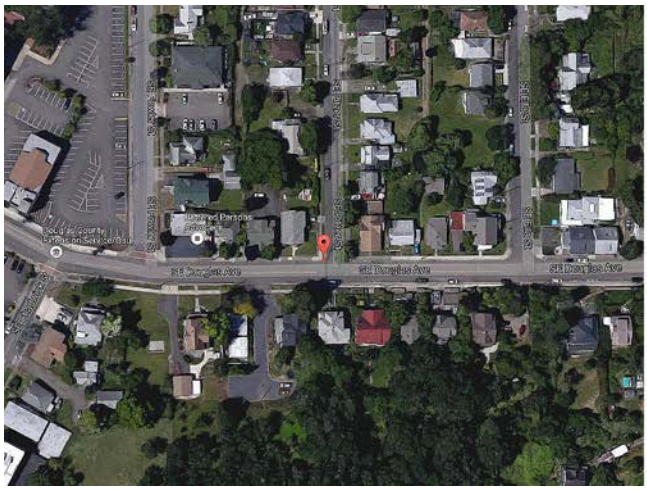
CR_226

Comments: Power pole in wing

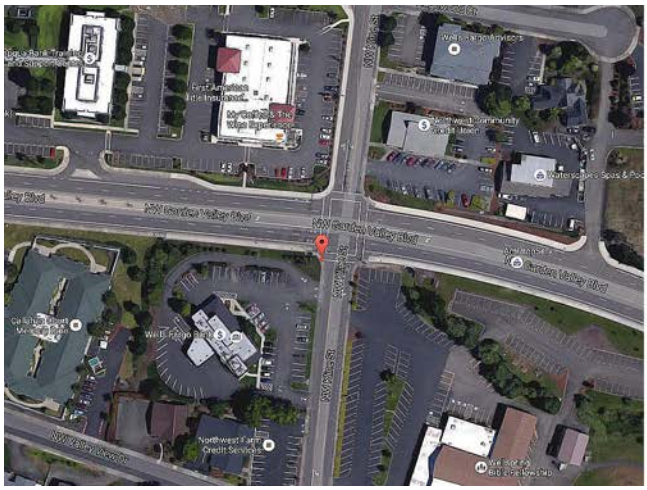
CR_361

Comments: Non compliant ramp no landing manhole in ramp

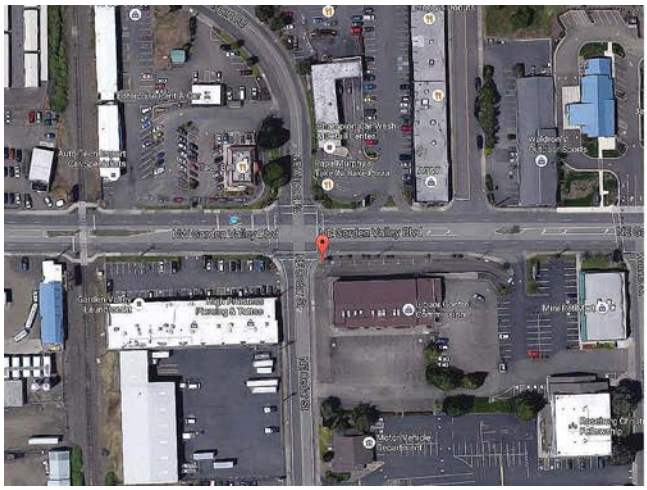
CR_568

Comments: Non compliant ramp no landing

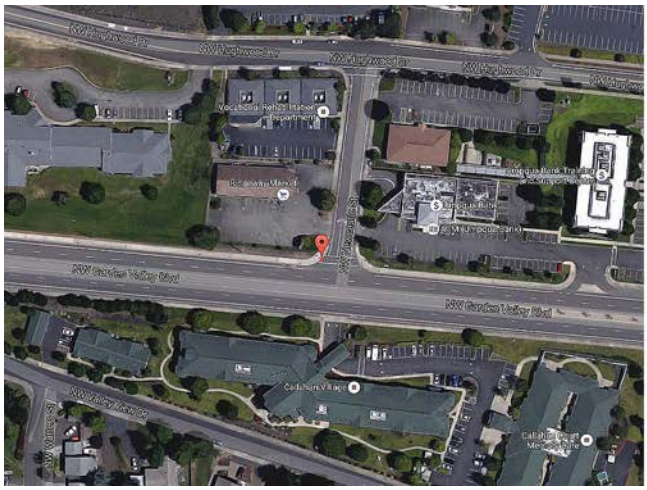
CR_577

Comments: Manhole in landing

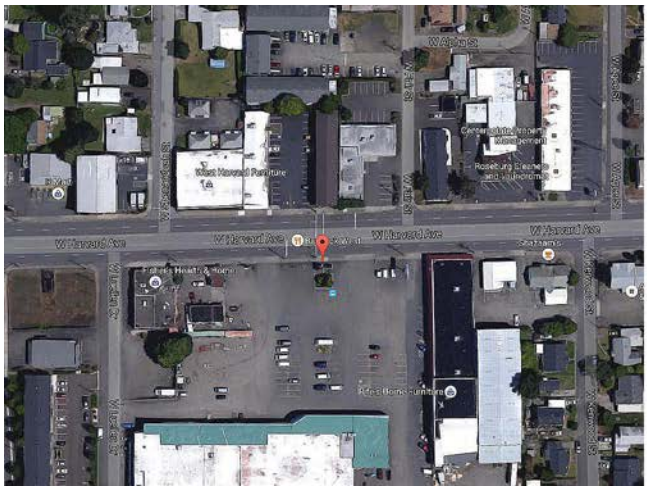
CR_671

Comments: No landing

S3_RampSlope: 10.0

S5_WingSlope1: 21.3

S6_WingSlope2: 23.7

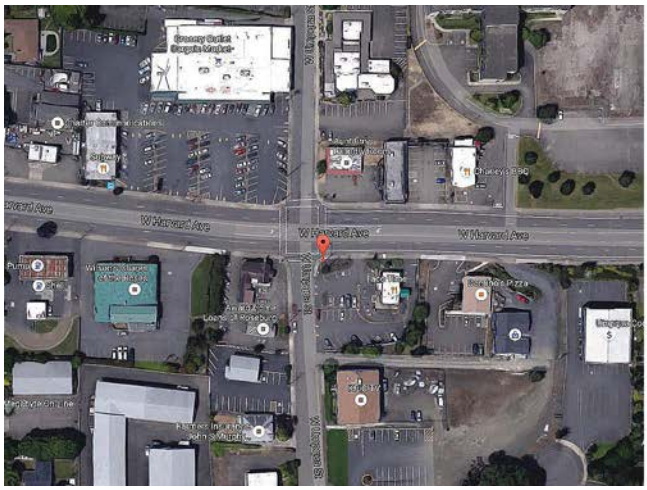
CR_692

Comments: No landing

S3_RampSlope: 12.4

S5_WingSlope1: 21.9

S6_WingSlope2: 18.3

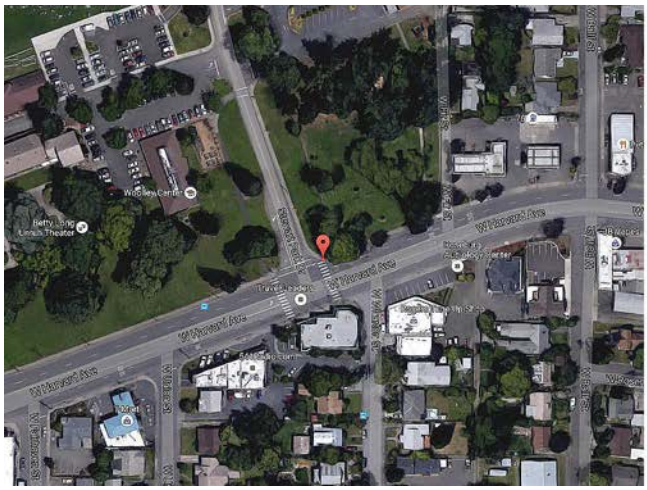
CR_697

Comments: No landing

S3_RampSlope: 11.6

S5_WingSlope1: 19.3

S6_WingSlope2: 15.2

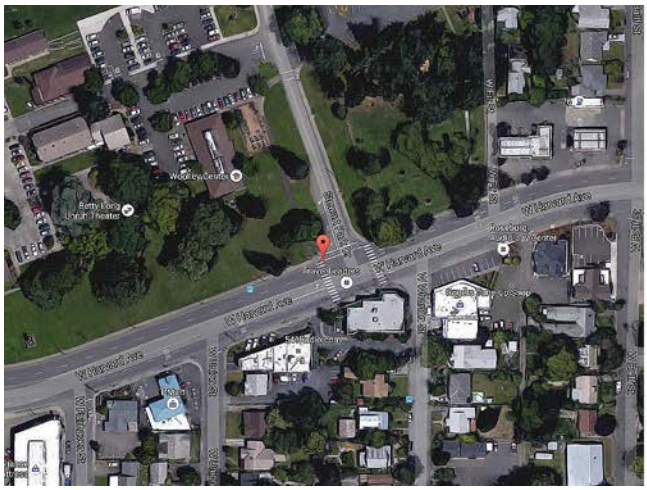
CR_698

Comments: No landing. Utility pole in landing/ramp

S3_RampSlope: 11.9

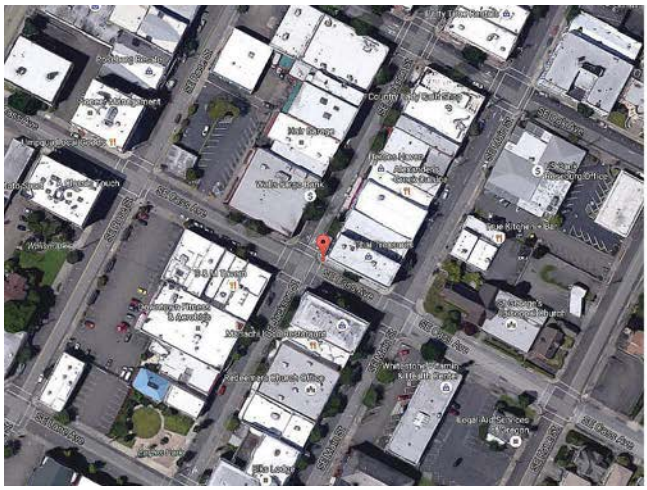
CR_111

Comments: Non compliant ramp

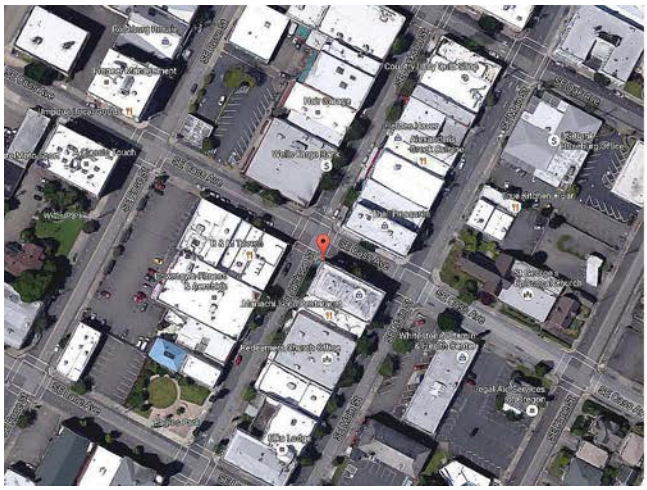
CR_112

Comments: Non compliant ramp

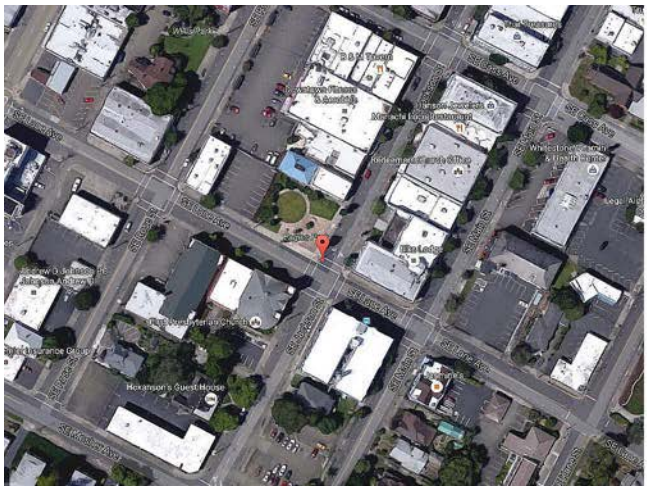
CR_168

Comments: On jackson. Poles in wings

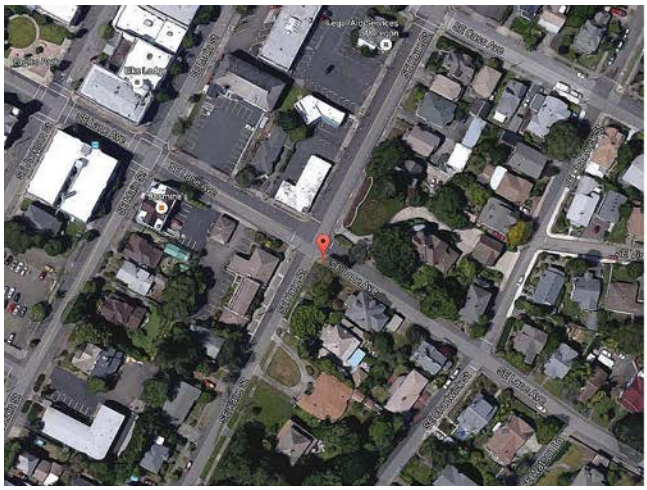
CR_126

Comments: Non compliant ramp

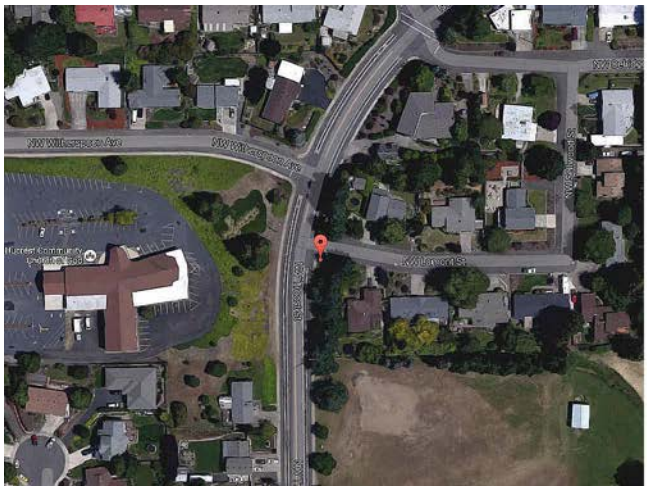
CR_379

Comments: Non compliant ramp no landing

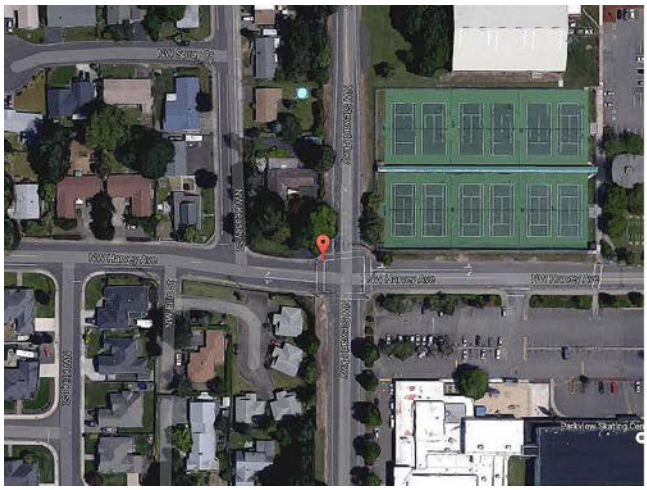
CR_324

Comments: Non compliant ramp no landing

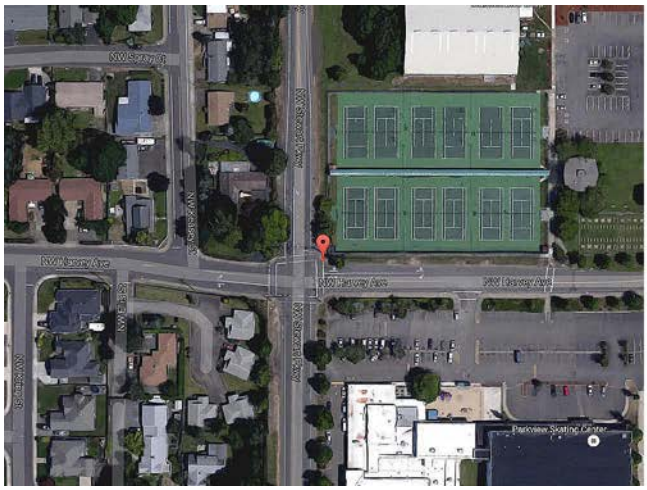
CR_411

Comments: No landing

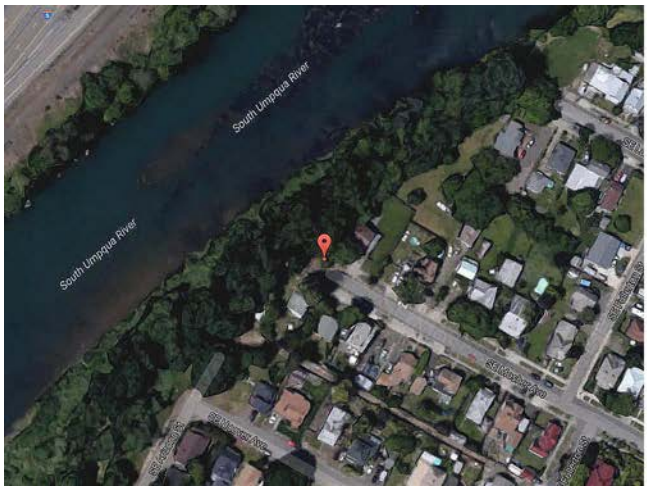
CR_856

Comments: Potential Landing in owners lot

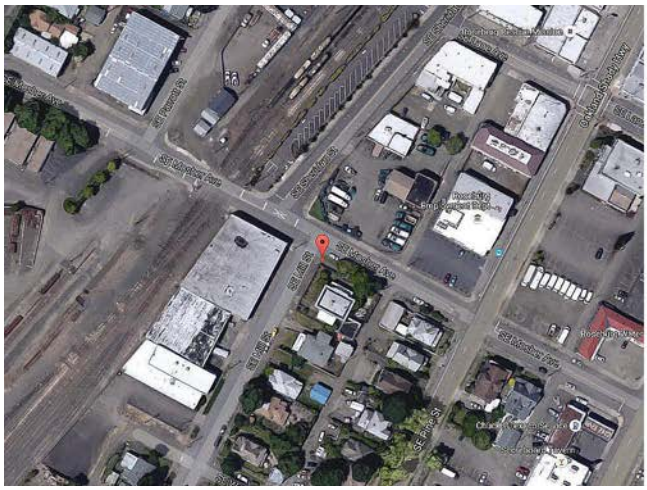
CR_183

Comments: Retaining wall in viable landing area

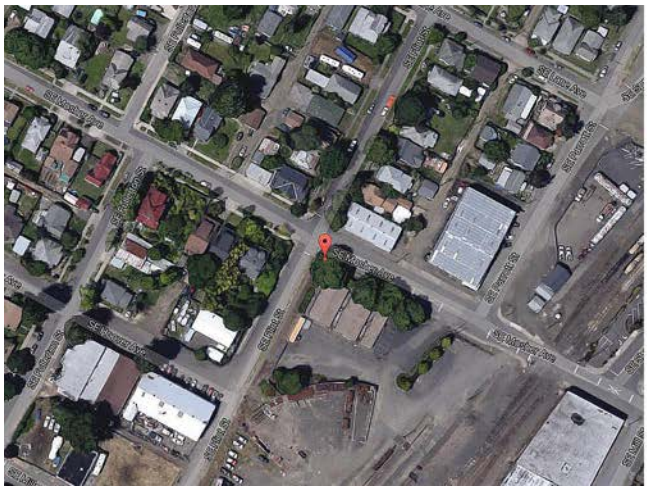
CR_186

Comments: No paved ramp. Potential gravel area usage

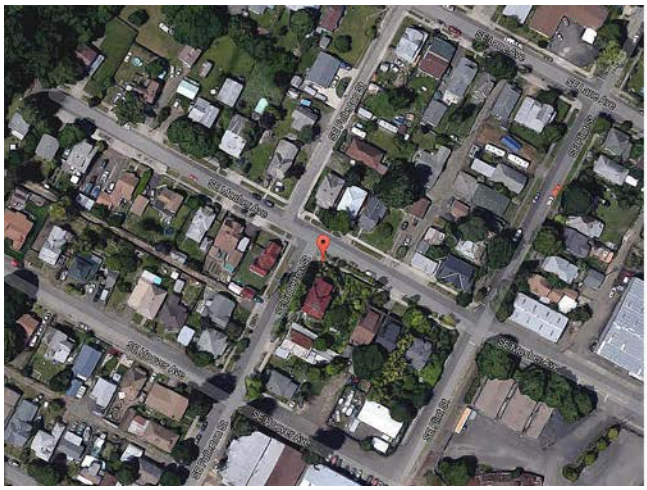
CR_189

Comments: No wings

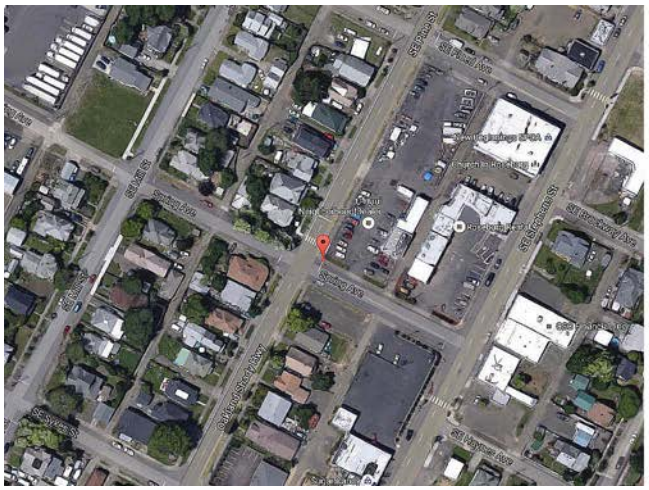
CR_242

Comments: Power pole at back of walk

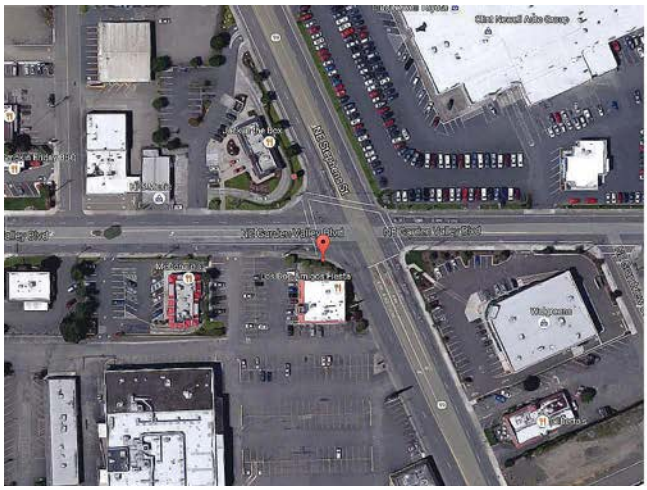
CR_605

Comments: No landing

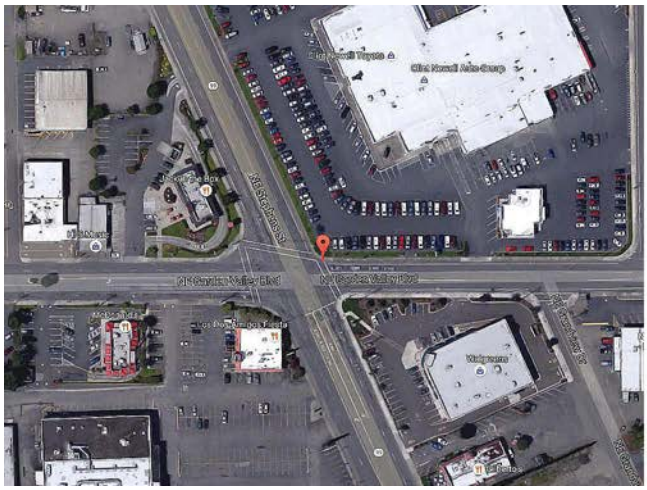
CR_635

Comments: Non compliant - no landing

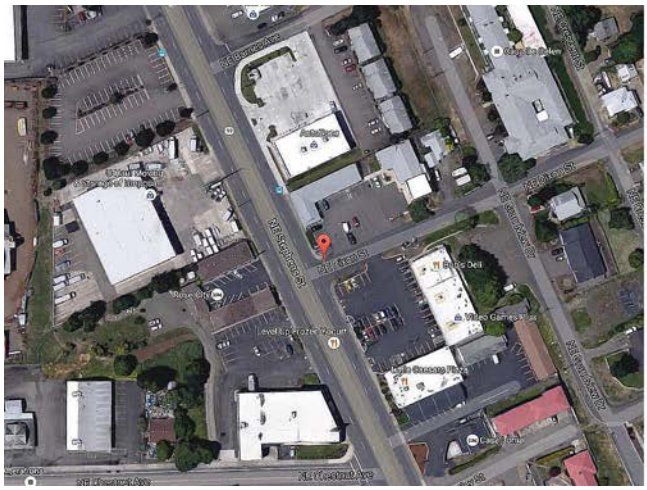
CR_644

Comments: Non compliant ramp no landing

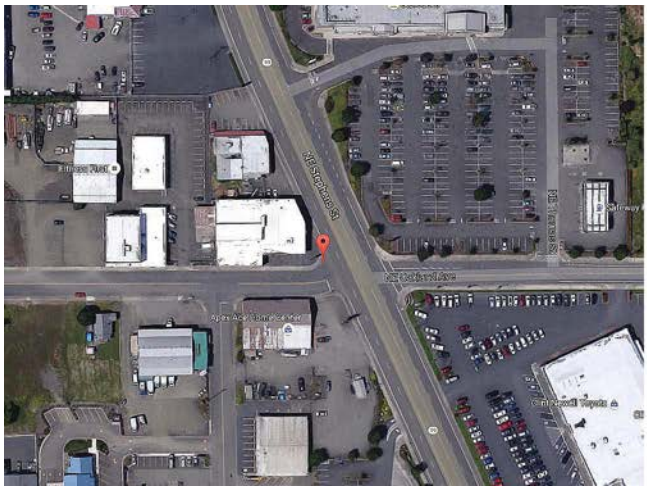
CR_676

Comments: No landing

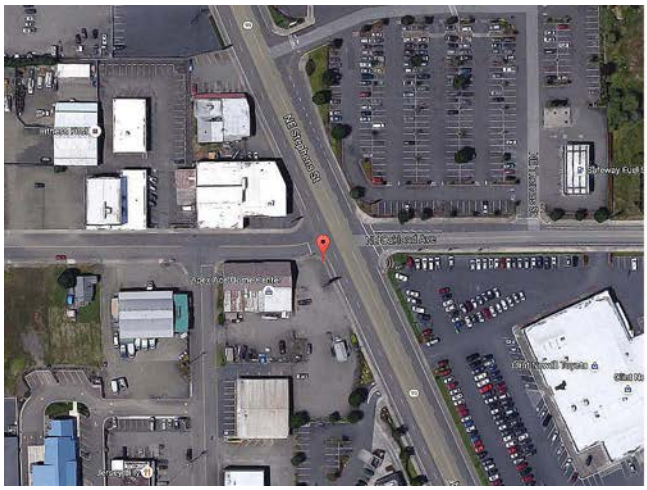
CR_677

Comments: No landing

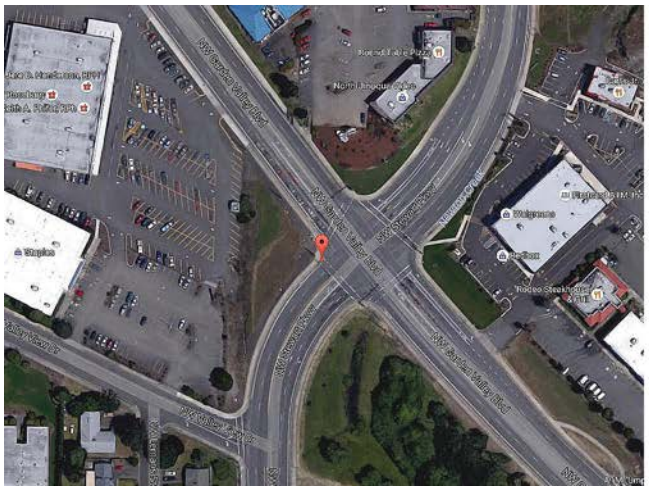
CR_315

Comments: On Stewart parkway

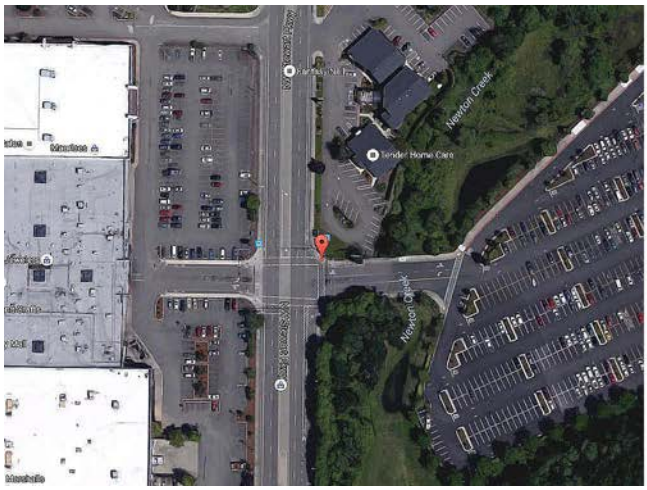
CR_317

Comments: Non compliant ramp no landing - on driveway

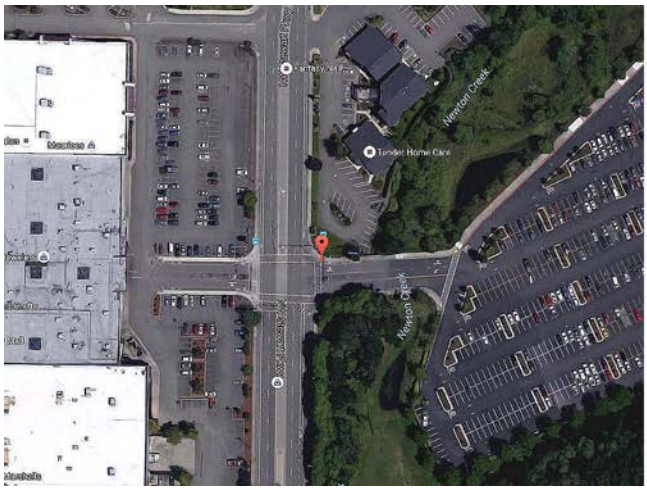
CR_318

Comments: Non compliant ramp - no landing - on Stewart pkwy

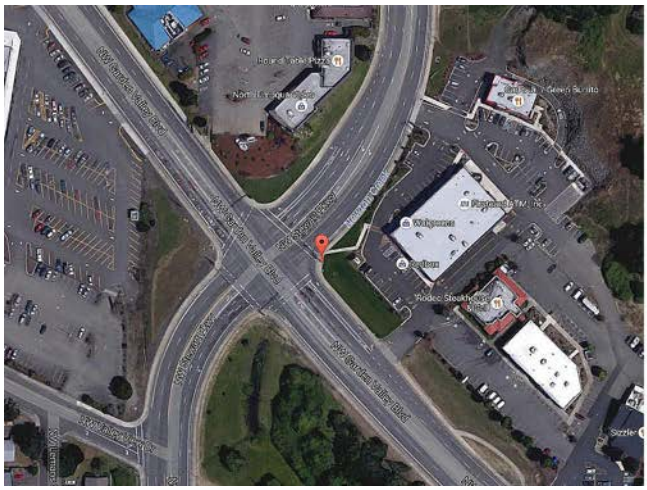
CR_399

Comments: On stewart

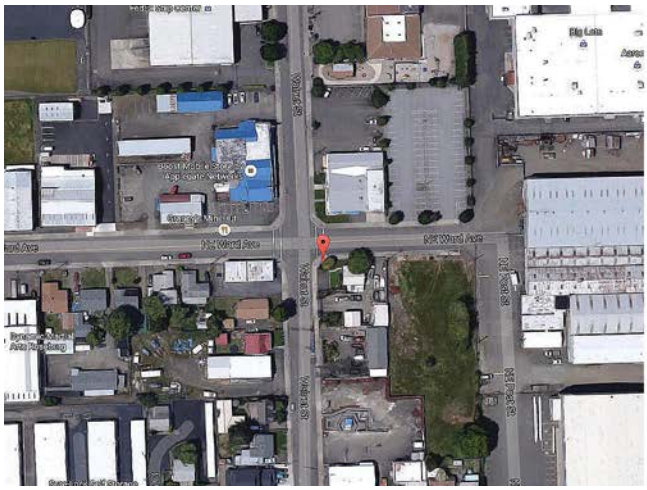
CR_525

Comments: On ward

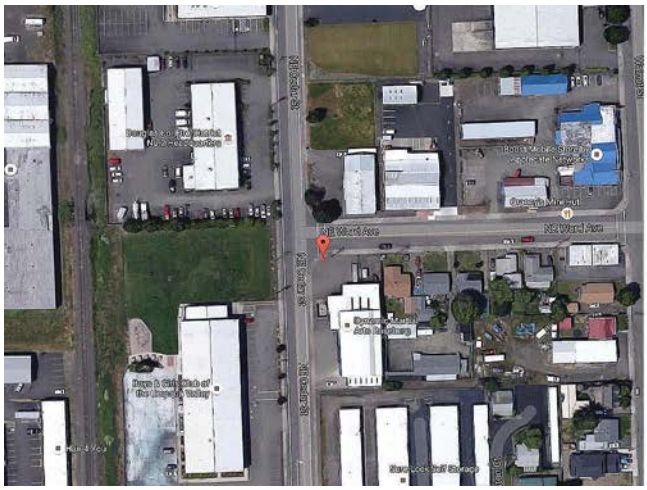
CR_566

Comments: Non compliant ramp no landing

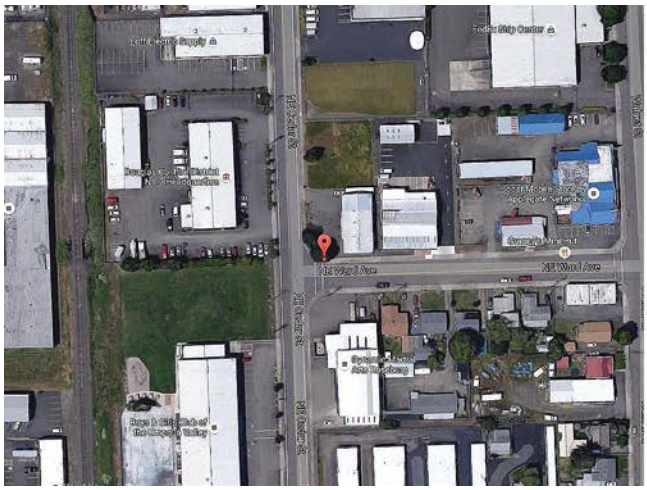
CR_567

Comments: Non compliant ramp no landing

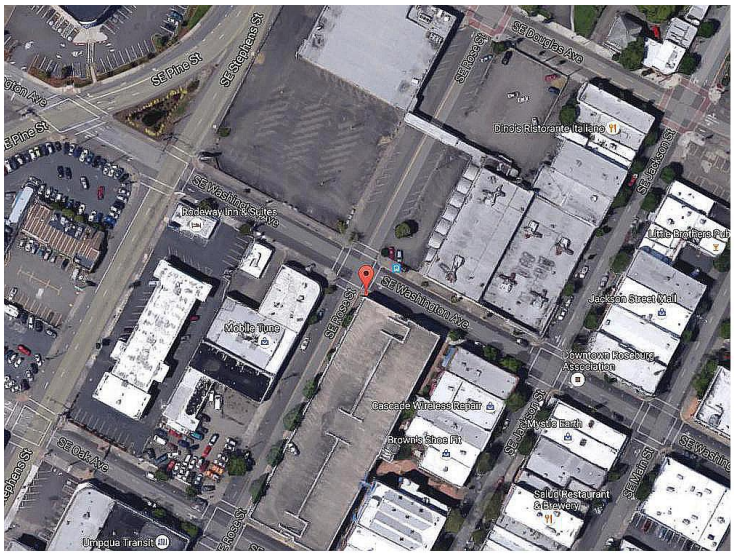
CR_35

Compliant: Verify

TruncDomes: Yes

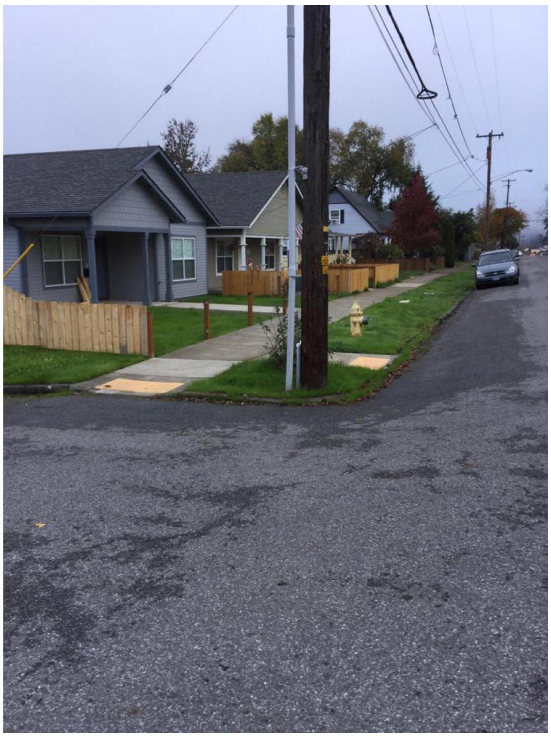
CR_36

Compliant: Verify

TruncDomes: Yes

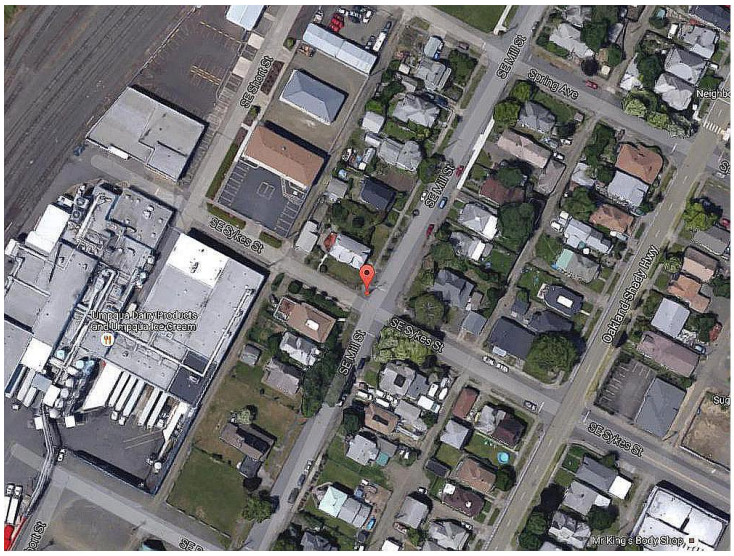
CR_37

Compliant: No

TruncDomes: No

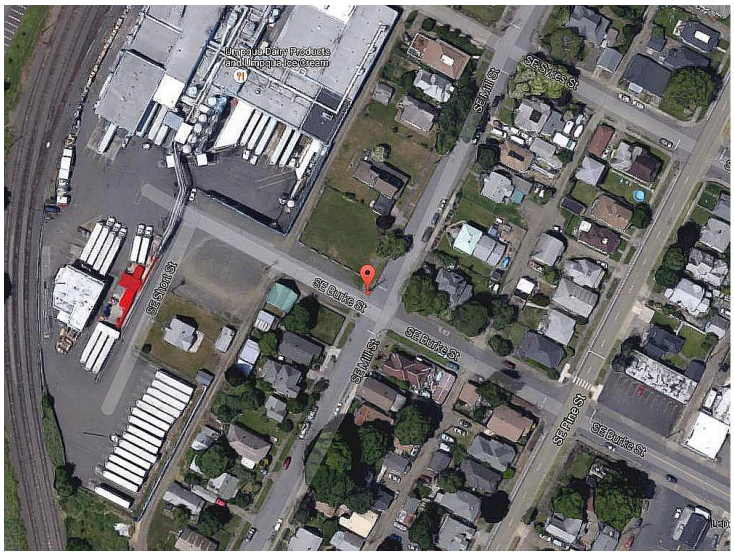
CR_39

Compliant: No

TruncDomes: No

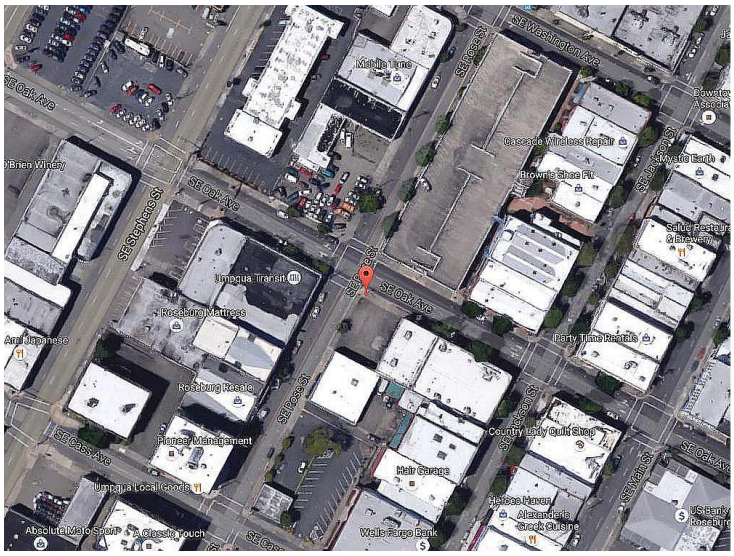
CR_40

Compliant: Verify

TruncDomes: Yes

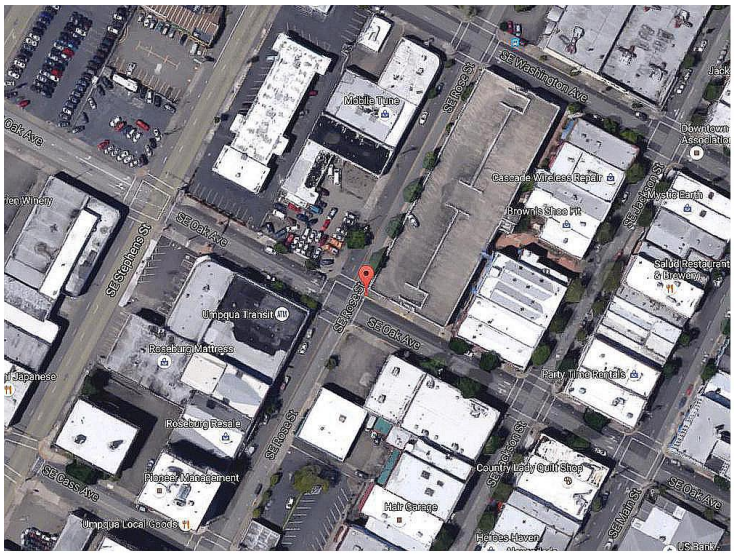
CR_41

Compliant: Verify

TruncDomes: Yes

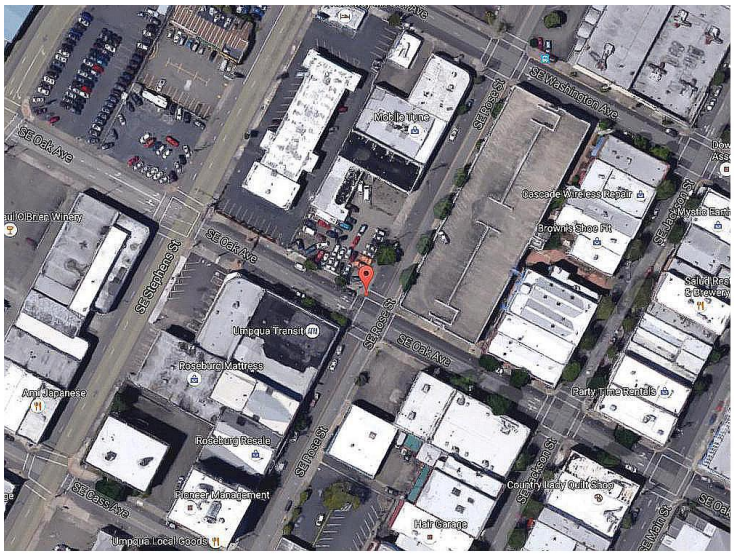
CR_42

Compliant: Verify

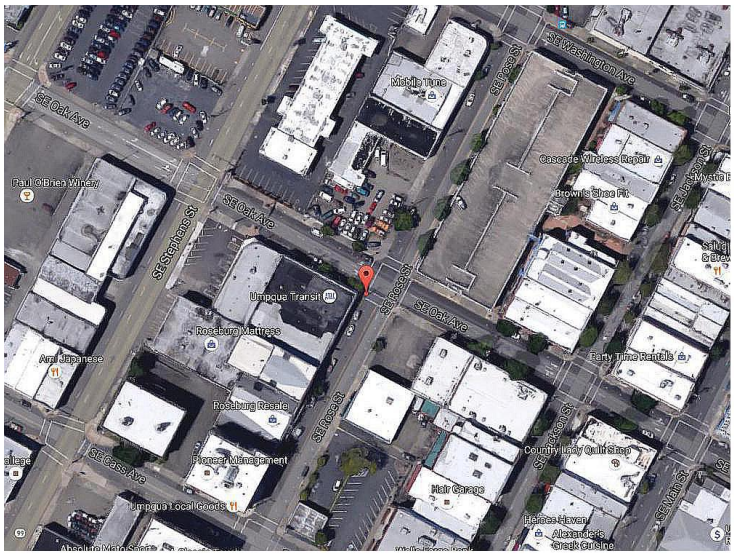
CR_43

Compliant: Verify

TruncDomes: Yes

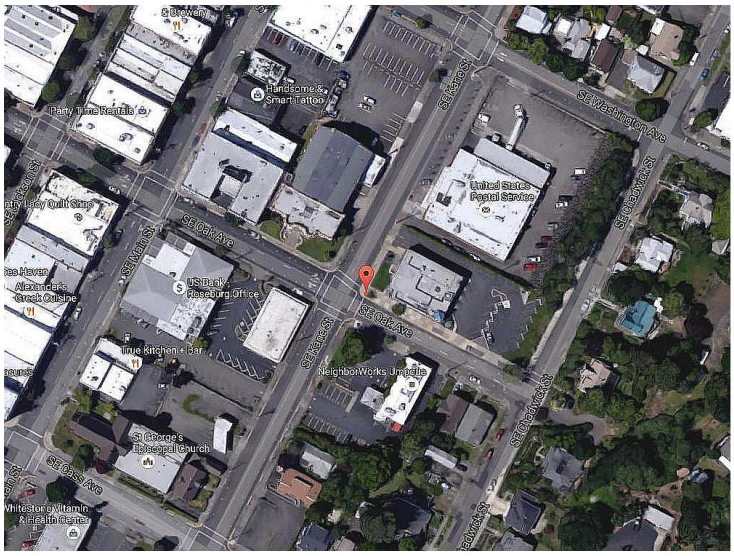
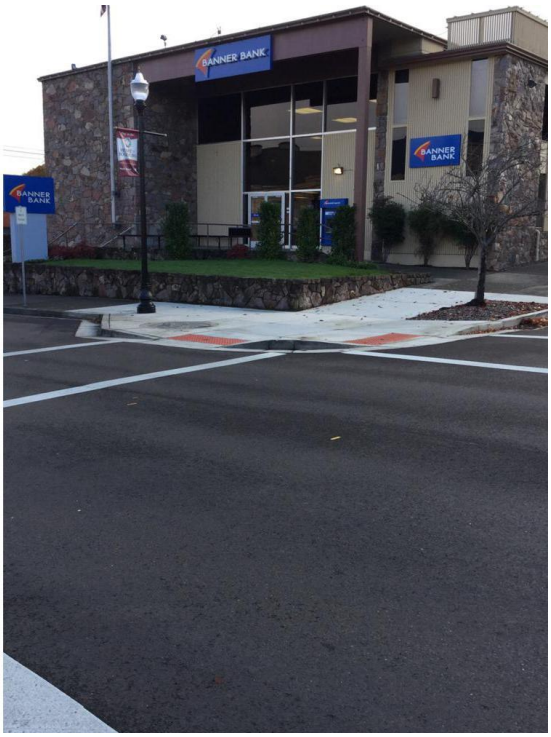
CR_44

Compliant: Verify

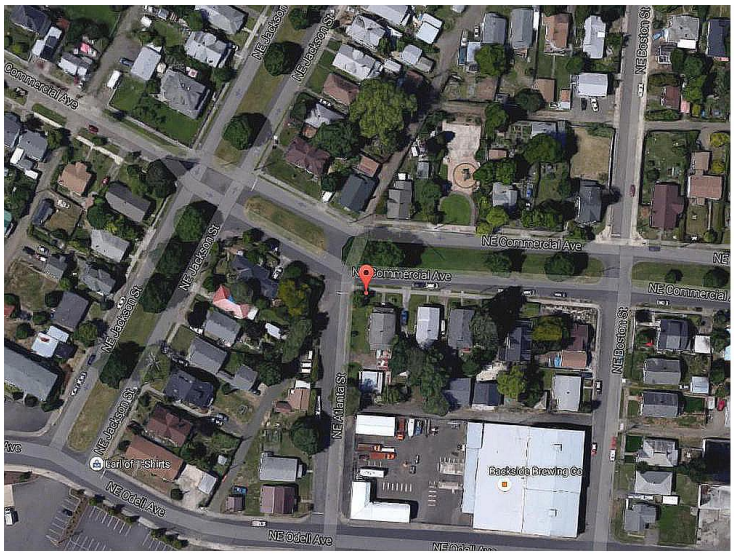
CR_71

Compliant: No

TruncDomes: No

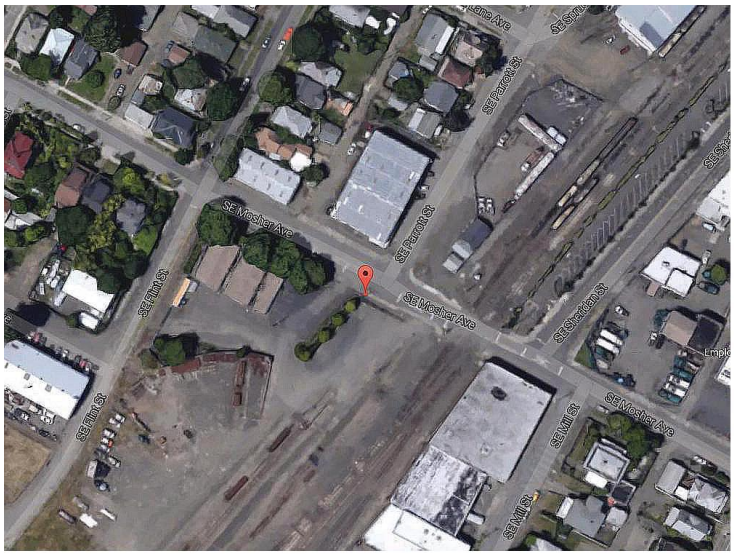
CR_72

Compliant: No

TruncDomes: No

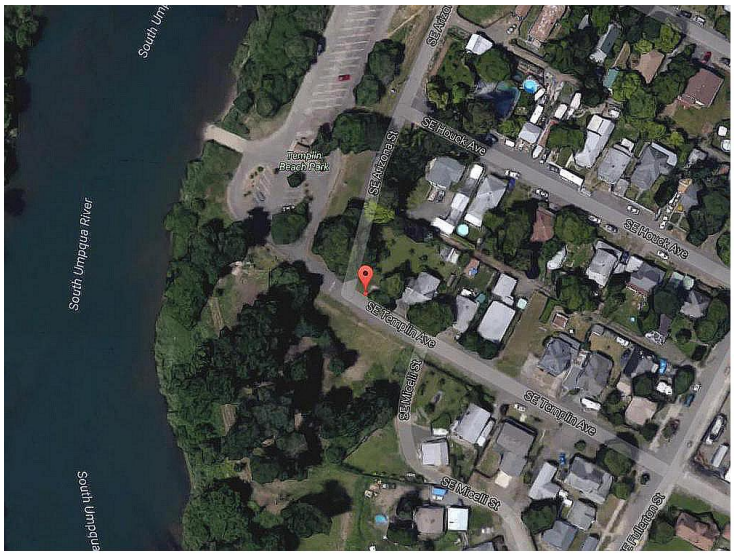
CR_73

Compliant: Verify

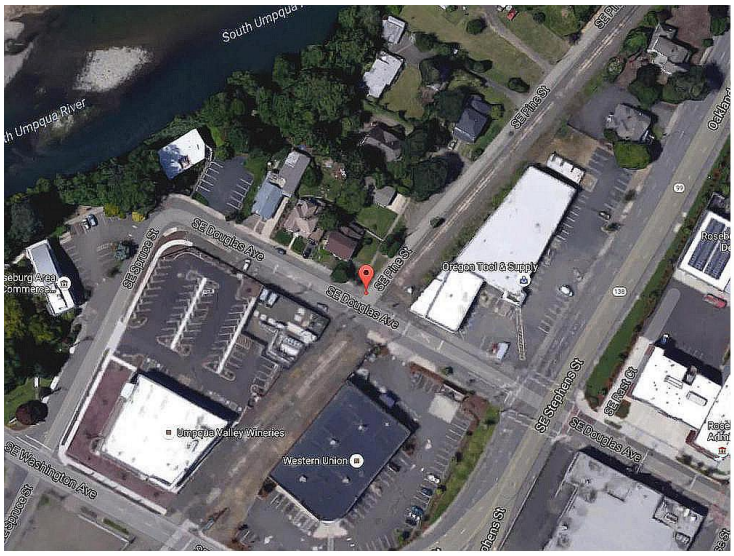
CR_74

Compliant: Verify

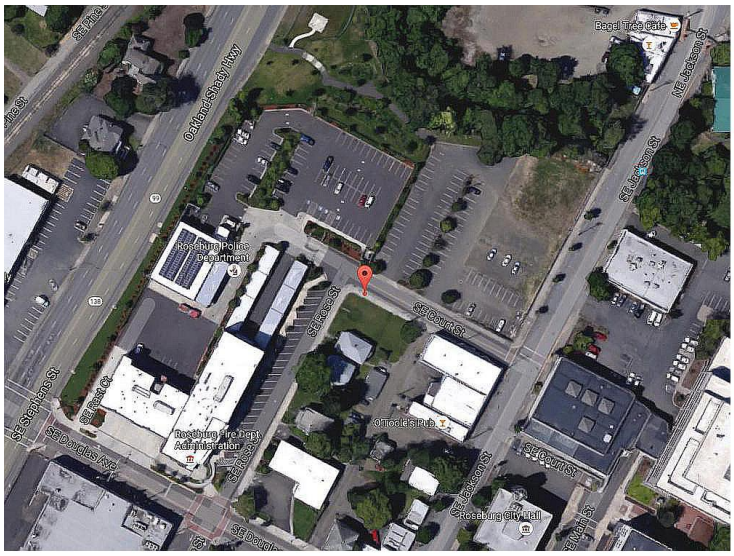
CR_75

Compliant: Verify
