# National Register of Historic Places Continuation Sheet

## Block K, Major Resources 81 - 86

**81: A Chapman, John and Mary Residence 1924**  
628 West Madrone Avenue Legal: pt. Blk.K  
Georgia Stiles, 428 NW Garden Valley Blvd. Roseburg, OR  
**Contractor:** Designer:  
Style: Bungalow Contributing: Primary  
Contributing Resources: 2 Non-Contributing Resources: 0

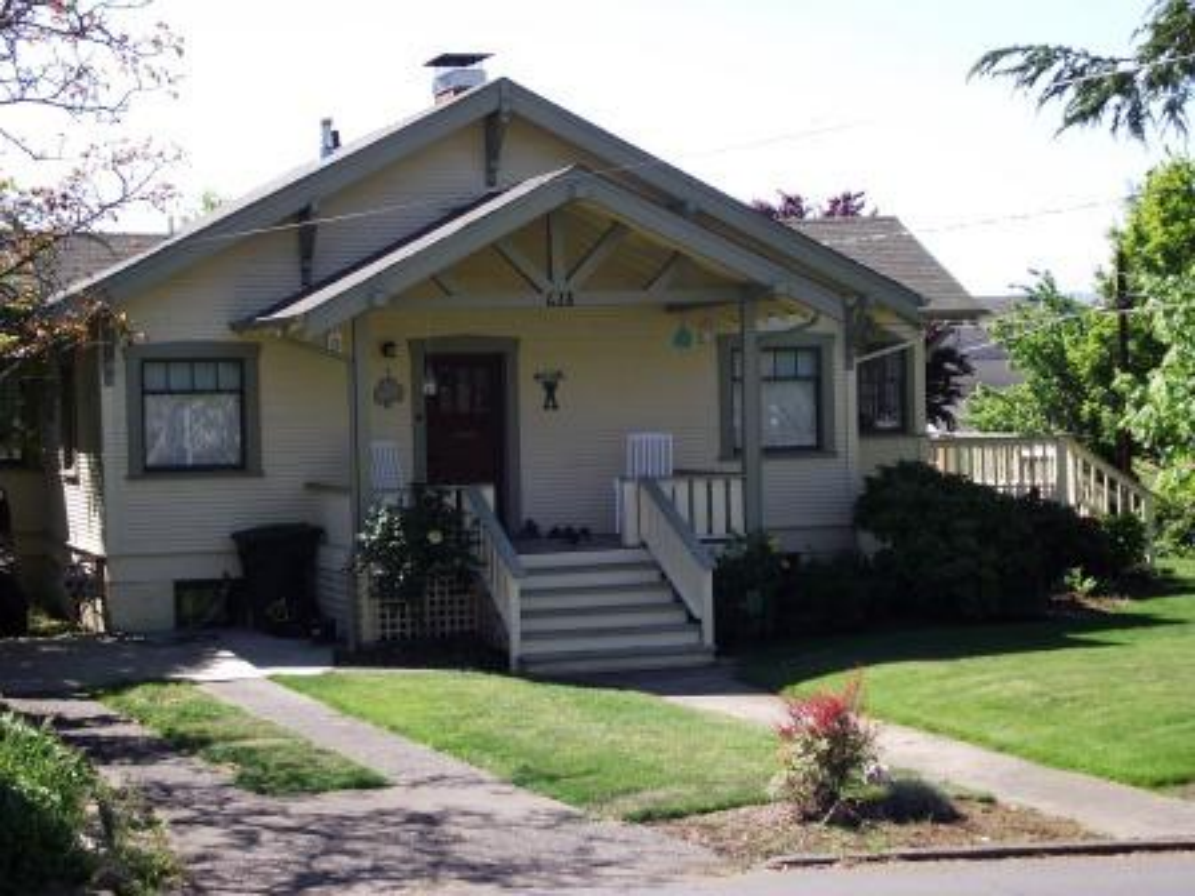
Description: This irregularly-shaped one-story house has a low-pitched cross gable roof with open eaves, bracketed purlin ends and composition shingles. The centered front-facing gabled porch has exposed truss work, small square corner supports, and a simple balustrade and railing with concrete steps. The windows are double hung multi-pane over one with wood sash. The building has narrow beveled siding, a concrete foundation and basement. It has an average setback with a large deodar cedar and other perennial plantings.
