# National Register of Historic Places Registration Form

historic name Roseburg Veterans Administration Hospital Historic District  
other names/site number Veterans Affairs Roseburg Healthcare System / N/A

street & number 913 Northwest Garden Valley Boulevard  not for publication  
city or town Roseburg  vicinity  
state Oregon code OR county Douglas code 019 zip code 97471

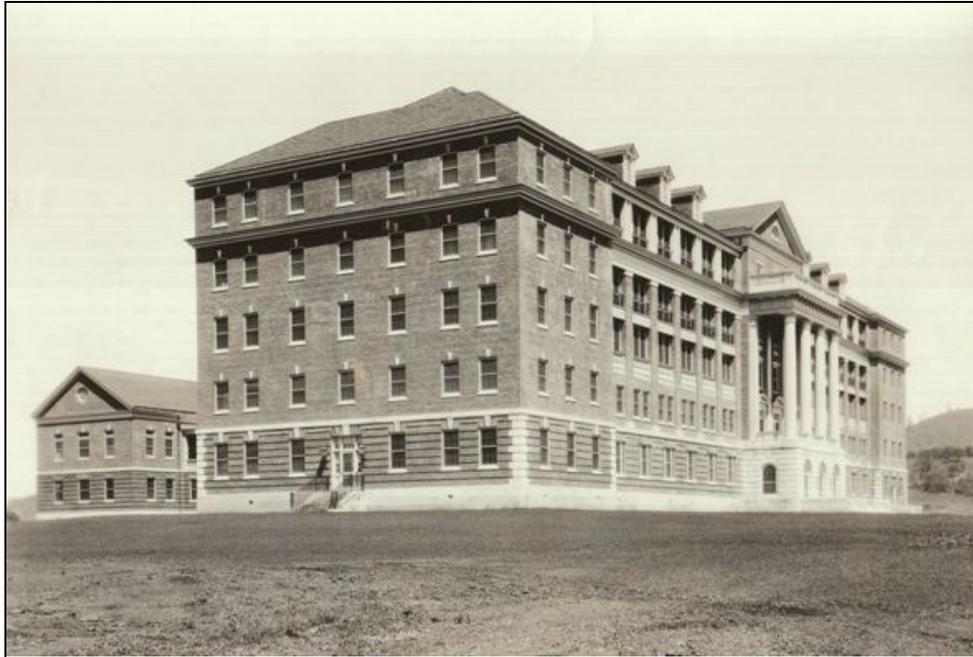
Figure 5: South and facade (east) elevations of Resource 1 (Main Building). Photograph dated May 27, 1933. Located in a scrapbook in the Public Affairs Office of the Veterans Affairs Roseburg Healthcare System, Roseburg, Oregon.

The first-floor platform of the portico is clad with banded stone rustication and exhibits two bays flanking a central double-leaf entry filled with commercial aluminum frame glass doors, all with fanlight transoms. The bays on each side of the entry are filled with two-light, single fixed replacement sashes. The three bays of the central pavilion’s first floor were originally filled with entry doors that led to the lobby.<sup>11</sup> The three bays are reached by granite stairs flanked by stone antepodia. The second floor of the central pavilion has three bays, and the central bay is filled with a louvered vent and features a segmental arch pediment with torus moldings of bay leaf bands. The central bay is flanked by entries filled with glazed French doors with transoms and elaborate door surrounds incorporating triangular pediments and similar torus moldings. The fourth- and fifth-story windows of the central pavilion exhibit jack arches with stone keystones and springers, and the third-story windows exhibit carved stone lintels with an urn and swag motif. Small, plain stone panels are located between the third- and fourth-floor windows of the central entrance pavilion.

The main block of the facade flanking the central pavilion is composed of five floors. The first floor exhibits banded brick similar to the banded stone on the first floor platform of the central pavilion. The bays of the first floor were originally filled with three-part windows, but are currently filled with paired single-over-single-light replacement sashes.<sup>12</sup> The second through fourth floors of the main block flanking the central pavilion are divided by large brick pilasters into six bays. Each bay of the second floor has two windows filled with single-over-single-light replacement sashes. The third, fourth, and fifth floors were originally open porches enclosed by screens but these have been filled in with brick, and sometimes two and more often three windows are centered within each bay. These windows are filled with horizontal two-over-two-light, double-hung, aluminum frame sashes. A wide cornice extends along the pilasters at the top of the fourth floor and ties into the cornice of the portico. The bays of the former open porches of the fifth floor are divided by paired, wood, square columns directly over the pilasters of the lower floors. The three-bay projections at each end of the facade elevation exhibit a hip roof, a narrow cornice between the fourth and fifth floors, brick jack arches with stone keystones above the window bays, and banded brick and stone quoins on the ground floor. A stone belt course is located above the ground floor windows and encompasses the building. A central, single-leaf entry door with sidelights and transom that was located on the ground floor of the north hip-roof projection has been removed (along with its stone steps) and replaced with a window filled with a multiple-light, fixed sash.<sup>13</sup> The central entrance pavilion is flanked by three gabled dormers with cornice returns, pilasters, and arched window openings. Five of these dormers are currently filled with louvered vents; one retains the original multiple-light, arched upper sash, with what appears to be a single-light lower sash.

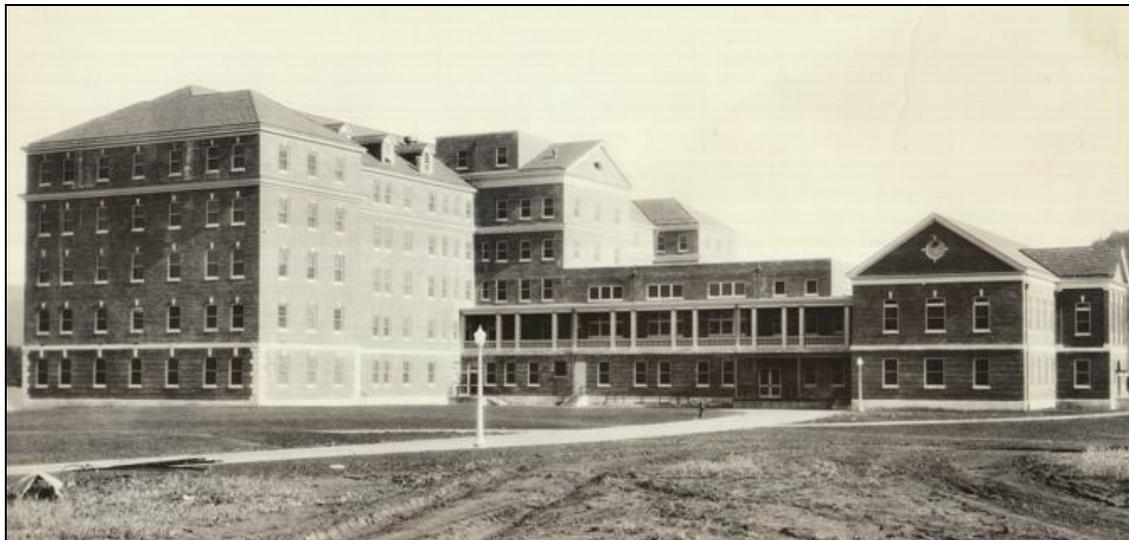
Figure 6: North and rear (west) elevations of Resource 1 (Main Building). Photograph dated May 27, 1933. Located in a scrapbook in the Public Affairs Office of the Veterans Affairs Roseburg Healthcare System, Roseburg, Oregon.

The rear elevation has a projecting, gable-roof, four bay central pavilion and gable roof projections at each end of the building's main block. The four-story central projecting pavilion has a pediment with a cornice, dentils, and an oculus window. Two gabled dormers with cornice returns, pilasters, and arched window openings are found on either side of the central pavilion. All the dormers are currently filled with louvered vents. On the ground floor, the central double-leaf entry is filled by commercial aluminum-frame glass doors. The central entry is flanked by a window with single-over-single-light, double hung replacement sashes and a single-leaf entry metal door. The three-bay second, third, and fourth floors of the central pavilion each have a central bay filled with paired windows, flanked by single windows. The fourth-floor windows are filled with six-over-six-light, double hung sashes, while the second and third floors have windows with single-over-single-light, double-hung sashes. A stone belt course is located above the third-floor windows and encompasses this pavilion.

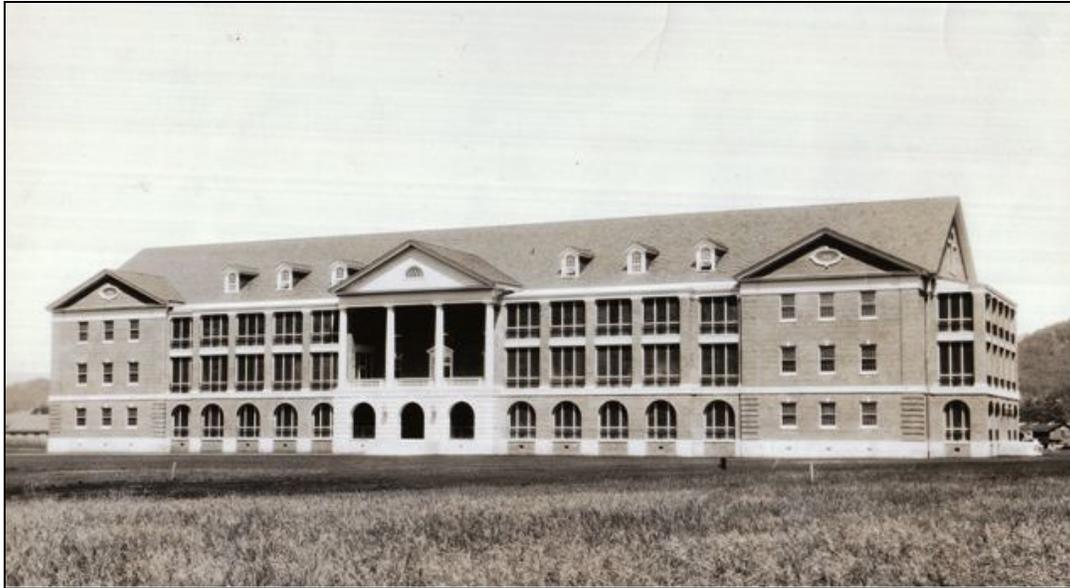
Figure 7: Facade (southeast) and northeast elevations of Resource 2 (Convalescent Building). Photograph dated May 27, 1933. Located in a scrapbook in the Public Affairs Office of the Veterans Affairs Roseburg Healthcare System, Roseburg, Oregon.

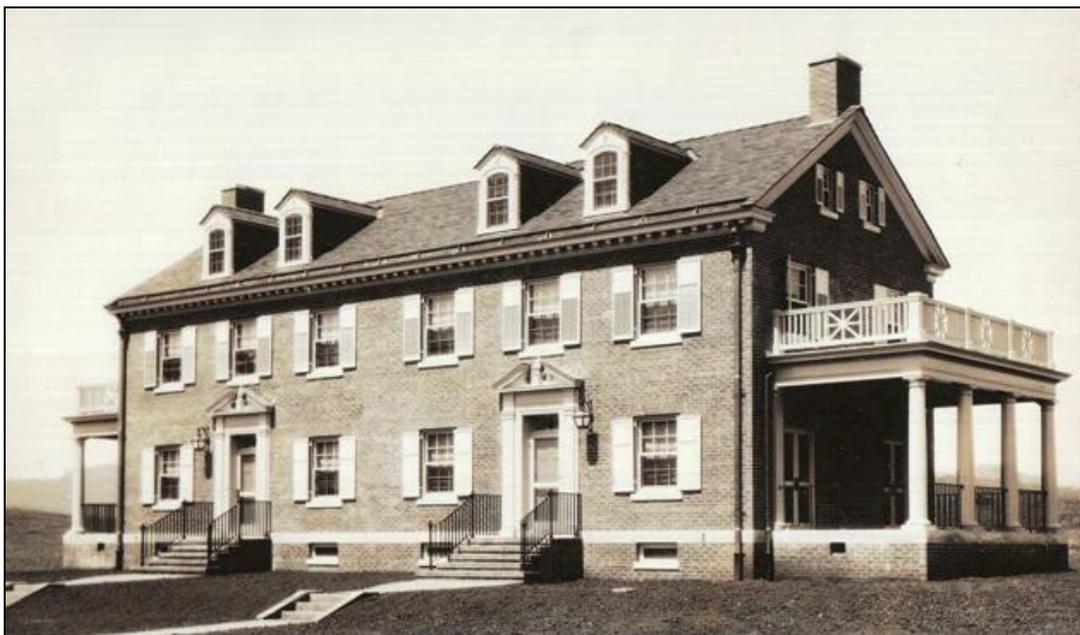
Figure 8: Facade (southeast) and northeast elevations of Resource 6 (Officers' Duplex Quarters). Photograph dated May 29, 1933. Located in a scrapbook in the Public Affairs Office of the Veterans Affairs Roseburg Healthcare System, Roseburg, Oregon.

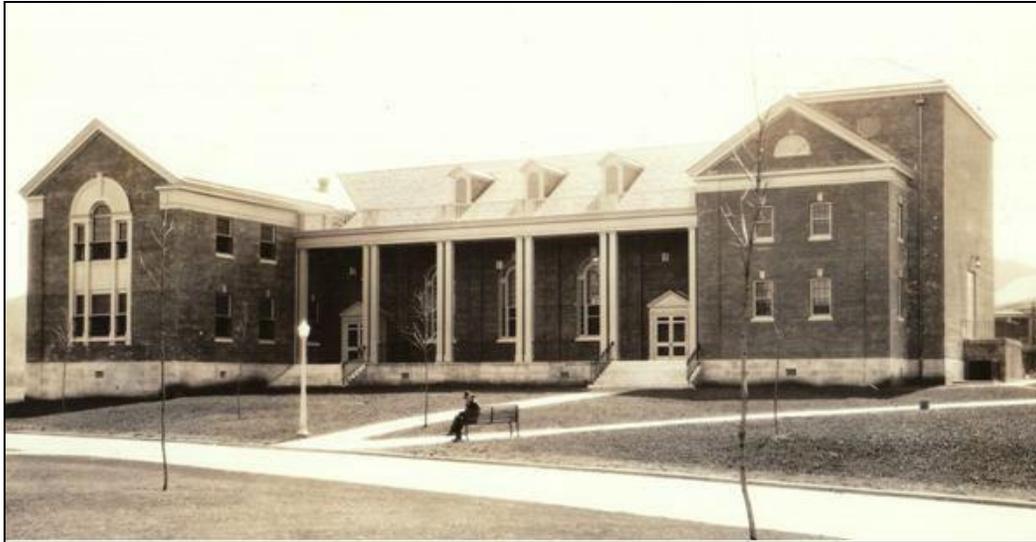
Figure 9: Northeast and rear (northwest) elevations of Resource 16 (Recreation Building). Photograph dated April 10, 1936. Located in a scrapbook in the Public Affairs Office of the Veterans Affairs Roseburg Healthcare System, Roseburg, Oregon.

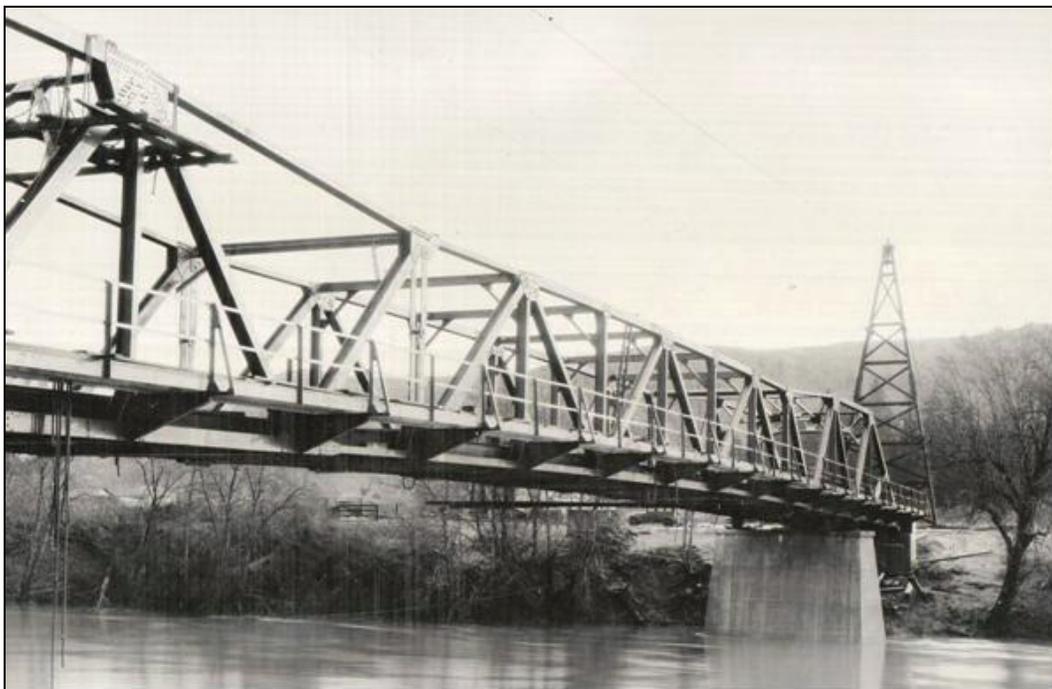
Figure 10: Bridge (Resource G) under construction spanning the South Umpqua River. Photograph dated December 12, 1932. Located in a scrapbook in the Public Affairs Office of the Veterans Affairs Roseburg Healthcare System, Roseburg, Oregon.

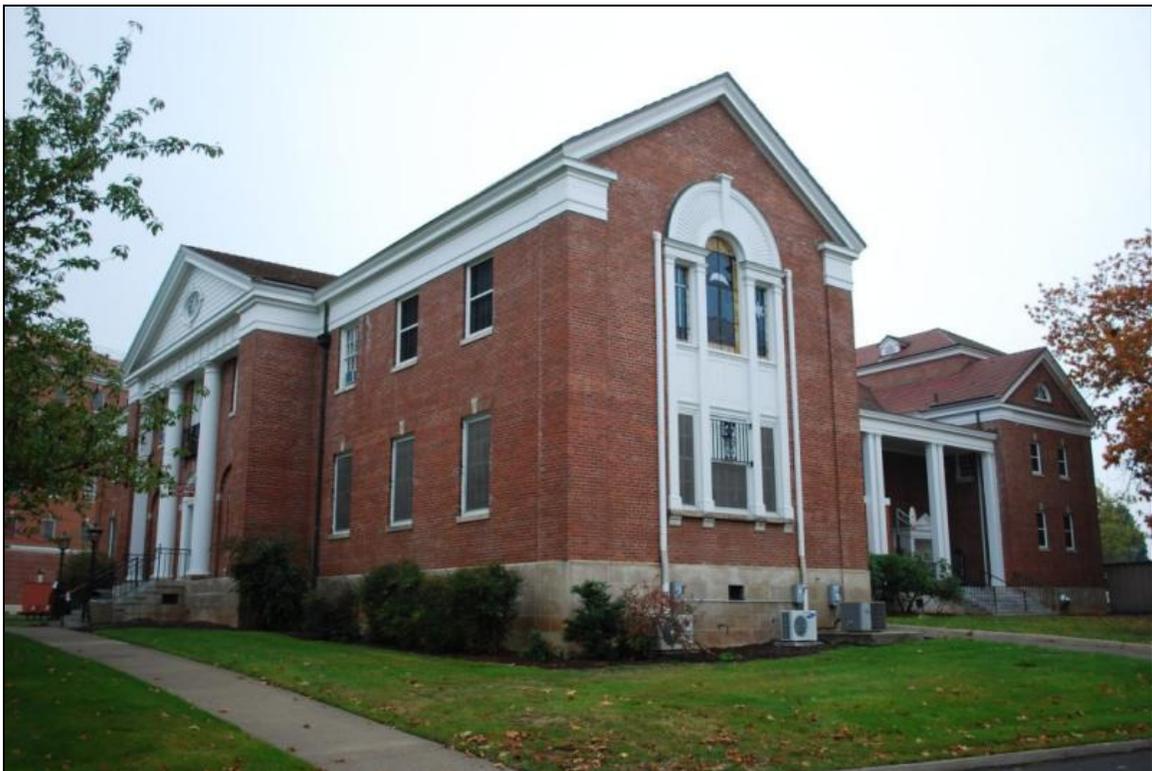
Photo 1 of 16: View to the west to the façade of Resource 1 and base of Resource K.

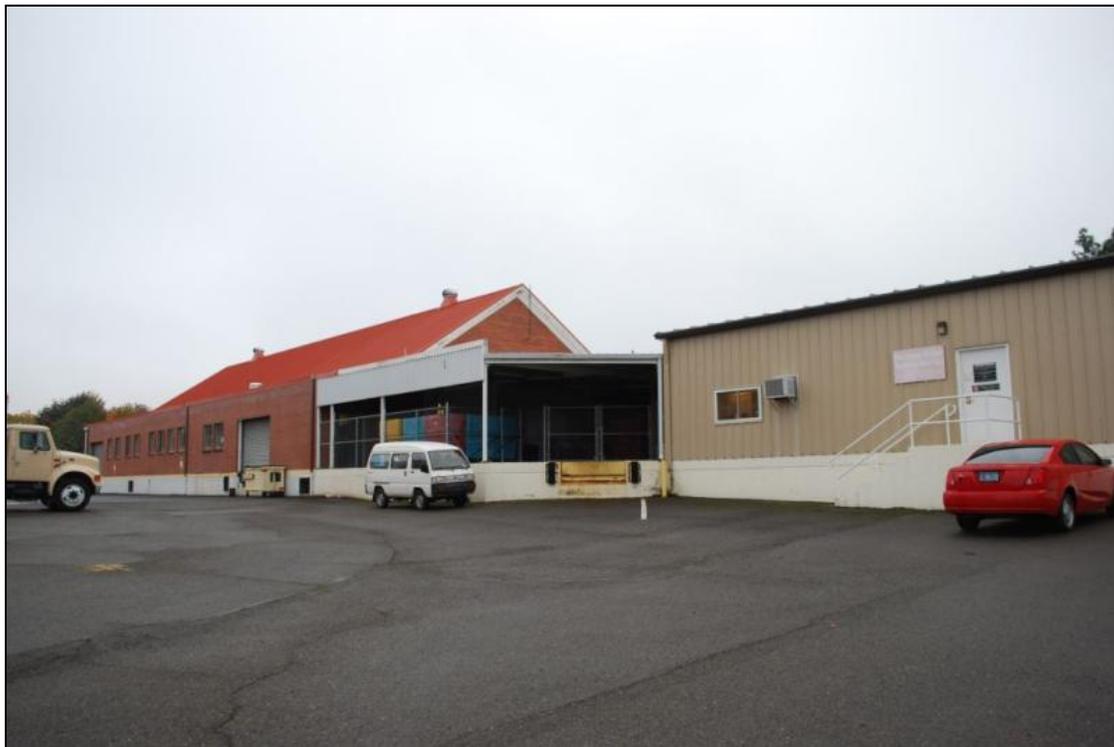
Photo 16 of 16: View looking to the east-southeast along the façade (northwest elevation) of Resource 11 and 11A.

Resource 11A was constructed circa 1985–2000 as an addition to the laundry building (Resource 11, 1933). It is oriented to the northwest and is located adjacent to the southwest elevation of Resource 11. The two-bay (d/w) single-story addition is supported by a concrete slab foundation and exhibits a ribbed-metal exterior and a ribbed-metal gable roof. The facade and rear elevations both exhibit single-leaf entries containing metal doors and windows filled by two single-light, horizontal sliding sashes. A circular vent projects from the right side (southwest elevation), and another projects from the roof in the southeast corner of the building. A loading dock sheltered by a flat roof located on the left side (northeast elevation) of this resource connects it with the laundry building (Resource 11, 1933).
